DEPARTMENT OF  
PUBLIC WORKS

CITY OF SACRAMENTO  
CALIFORNIA

SUBJECT: Investigation and Repair of Suspender Cables on the Guy  
West Bridge (PN:HA51) - For Committee Information

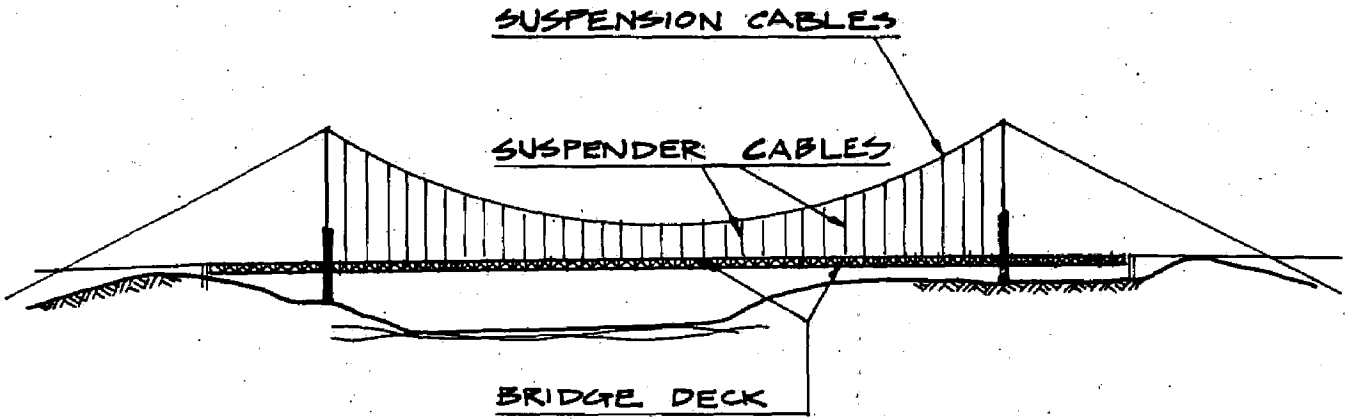
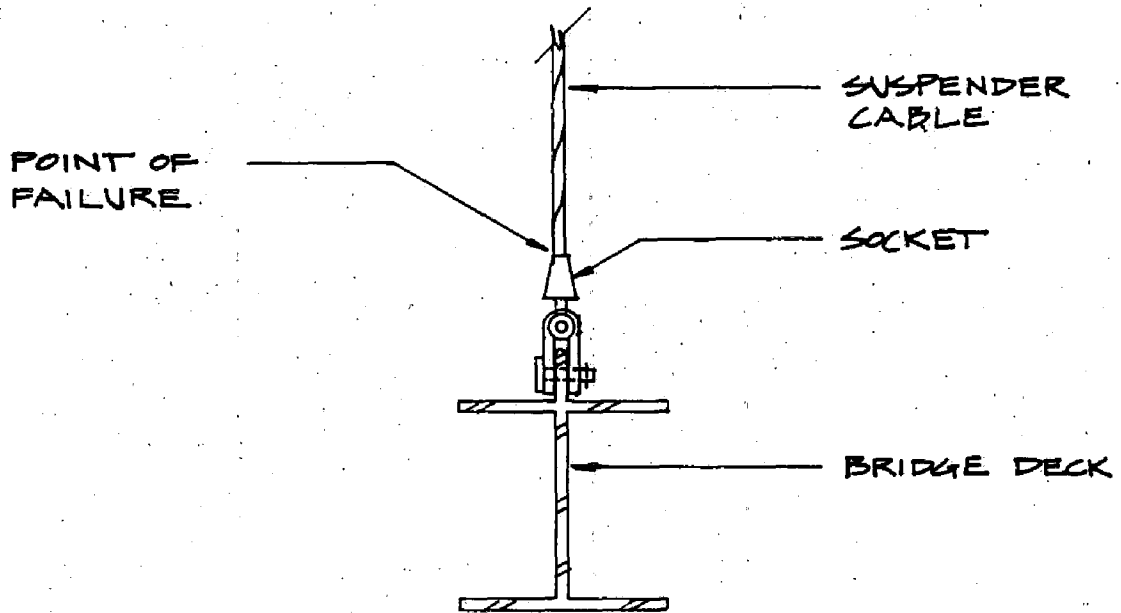
GUY WEST BRIDGE

The study by Wiss, Janney, Elstner Associates, Inc., titled "Investigation of Suspender Failures and Recommendation for Bridge Repairs for the Guy West Bridge" and dated February 12, 1990, concludes that the primary cause of the suspender cable failures was due to fatigue of the steel wires which make up the suspender cables. The point of failure was located at the top of the socket connection to the bridge deck. The fatigue was caused primarily by the overhead suspension cables swaying relative to the bridge deck. (See attached Exhibit A which identifies the point of failure).

Several possible design alternatives were evaluated that would reduce the fatigue experienced in the existing suspender cables and yet maintain the aesthetic appearance of the existing structure. It was determined that the most economical long-term solution was to replace the existing suspender cables with only minor design modifications and to subsequently replace the suspender cables periodically (every 20 years or so) as fatigue occurs. A maintenance program which may lengthen the life of the suspender cables is described in the report. The maintenance program will be implemented by the Public Works Department as part of its routine bridge maintenance program.
