Site Address: 305 21ST ST SAC

Nature of Work: DRY ROT REPAIR - REPLACE SIDING AND 2 OR 3 FLOORE JOISTS.
SEE PESTS REPORT

# WOOD DESTROYING PESTS AND ORGANISMS REPORT

BUILDING NO. 305	STREET 21st Street	CITY Sacramento	ZIP 95814	COUNTY CODE 34	DATE OF INSPECTION 08/24/2000	# OF PAGES 7
---------------------	-----------------------	--------------------	--------------	-------------------	----------------------------------	-----------------

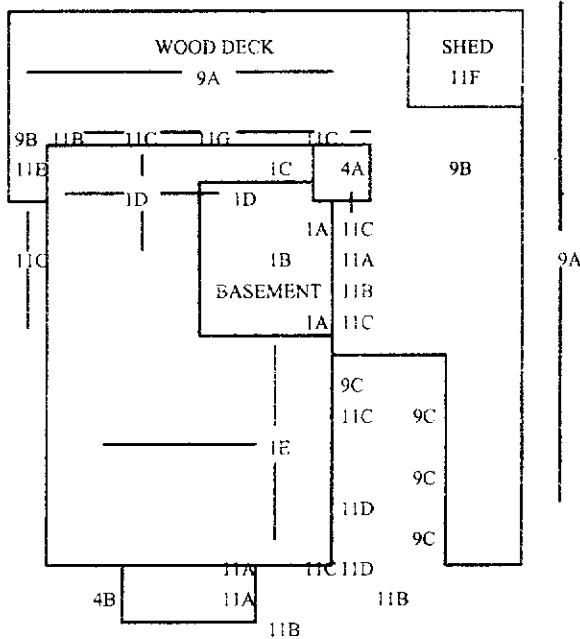
**DIAGRAM AND EXPLANATION OF FINDINGS (This report is limited to structure shown on diagram) Diagram not to scale**

- 1A Fungus (dry rot) damage was noted to the 2x4 wall studs and mud sill on the right side of the structure. See 1A on diagram.

- 1B Plumbing leak was noted beneath the kitchen sink. See 1B on diagram.

1C Fungus (dry rot) damage was noted to the 1x4 subfloor and 4x6 joist beneath the rear porch. See 1C on diagram.

1D Fungus growth noted to the subfloor beneath the laundry room. See 1D on diagram.

1E Portions of the subarea are inaccessible due to no access opening. See 1E on diagram.

4A Fungus (dry rot) damage was noted to the 2x12 stair jack and 2x6 steps at the rear wood porch. See 4A on diagram.

4B Earth-to-wood contact noted to the lattice on the left side of the front porch. See 4B on diagram.

9A Portions of the rear attached wood deck were noted to be inaccessible for inspection due to lack of clearance between the soil and wood members. See 9A on diagram.

9B Fungus (dry rot) damage was noted to approximately 40 lineal feet of 2x6 deck boards. See 9B on diagram.

9C Fungus (dry rot) damage was noted to approximately four 4x4 support posts and pads at the wood deck. See 9C on diagram.

11A Fungus (dry rot) damage was noted to the 1x4 soffits at the front porch and right side of the structure. See 11A on diagram.

11B Fungus (dry rot) damage was noted to the 1x6 fascia at the front, rear, and right side of the structure. See 11B on diagram.

11C Fungus (dry rot) damage was noted to approximately 140 lineal feet of 1x5 lap siding. See 11C on diagram.

11D Fungus (dry rot) damage was noted to the 1x3 corner trim at the front of the structure. See 11D on diagram.

11E Fungus (dry rot) damage was noted to the 1x3 left side window trim. See 11E on diagram.

11F Portions of detached wood shed were noted to be inaccessible for inspection due to storage. See 11F on diagram.

RECOMMENDATION: Remove and replace damaged wood members with new material and treat adjacent or exposed wood members with an approved chemical fungicide (COPPER NAPHTHENATE) to correct the above noted condition. ATTENTION: During the performance of repairs at the above mentioned areas, should any additional damage or conditions be found that were not visible or accessible at the time of the inspection without removing lumber or finished products, the owner or their representative will be contacted for direction.

RECOMMENDATION: Make necessary repairs to correct the above reported leak. ATTENTION: Treat adjacent wood members with an approved fungicide.

RECOMMENDATION: From the subarea, remove and replace visibly damaged wood members with new material and re-support as needed. Treat adjacent wood members with an approved chemical fungicide (COPPER NAPHTHENATE). ATTENTION: If damage cannot be fully removed from the subarea or extends into areas not accessible, a Supplemental Report will be issued on findings and owner or their representative will be contacted with additional costs.

RECOMMENDATION: Remove all visible surface fungus growth and apply an approved chemical fungicide (COPPER NAPHTHENATE) to infected area(s).

RECOMMENDATION: Install adequate sized permanent opening to gain access into area and issue a Supplemental Report on findings.

RECOMMENDATION: Remove and replace damaged stair jacks and/or steps with new material to correct the above noted condition. ATTENTION: During the performance of repairs at the above mentioned areas, should any additional damage or conditions be found that were not visible or accessible at the time of the inspection without removing lumber or finished products, the owner or their representative will be contacted for direction.

RECOMMENDATION: Lower soil away from wood members to correct earth-to-wood contact. ATTENTION: During the performance of repairs at the above mentioned areas, once the soil is lowered, if any additional damage or infestation is noted to wood members that was not visible or accessible at the time of inspection. A Supplemental Report will be issued on findings and owner or their representative will be contacted with additional cost.

RECOMMENDATION: Remove portions of decking to allow for inspection for wood members under deck and issue a Supplemental Report on findings. ATTENTION: During the performance of repairs at the above mentioned areas, should any additional damage or conditions be found that were not visible or accessible at the time of the inspection without removing lumber or finished products, the owner or their representative will be contacted for direction.

RECOMMENDATION: Remove and replace damaged wood decking with new material. ATTENTION: If damage exceeds specified footage or any additional damage is found a Supplemental Report will be issued on findings and owner or their representative will be contacted with additional costs. ATTENTION: During the performance of repairs at the above mentioned areas, should any additional damage or conditions be found that were not visible or accessible at the time of the inspection without removing lumber or finished products, the owner or their representative will be contacted for direction.

RECOMMENDATION: Remove and replace damaged wood members with new material and treat adjacent or exposed wood members with an approved chemical fungicide (COPPER NAPHTHENATE) to correct the above noted condition. ATTENTION: Application of caulking or sealant is considered a normal homeowner repair and MILLENNIUM TERMITE will not guarantee against future leaks of this type.

RECOMMENDATION: Remove the damaged 1x4 enclosed soffit(s). Inspect wood members for additional damage and treat with an approved chemical fungicide (DISODIUM, OCTABORATE and TETRAHYDRATE SOLUTION). Reinstall new soffit(s) to match as close as possible. ATTENTION: If additional damage is found, a Supplemental Report will be issued on findings and owner or their representative will be contacted with additional costs. ATTENTION: Application of caulking or sealant is considered a normal homeowner repair and MILLENNIUM TERMITE will not guarantee against future leaks of this type.

RECOMMENDATION: Remove and replace approximately 140 lineal feet of damaged siding with new to match existing as close as possible. ATTENTION: If additional damage is found a Supplemental Report will be issued on findings and owner or their representative will be contacted with additional costs. ATTENTION: MILLENNIUM TERMITE is not responsible for any texture or painting that may be necessary.

RECOMMENDATION: Remove storage away from wall to allow for further inspection.
