CITY OF SACRAMENTO

Nature of Work: DRY ROT REPAIR - REPLACE SIDING AND 2 OR 3 FLOORE JOISTS.
SEE PESTS REPORT

# WOOD DESTROYING PESTS AND ORGANISMS REPORT

BUILDING NO. 305	STREET 21st Street	CITY Sacramento	ZIP 95814	COUNTY CODE 34	DATE OF INSPECTION 08/24/2000	# OF PAGES 7
---------------------	-----------------------	--------------------	--------------	-------------------	----------------------------------	-----------------

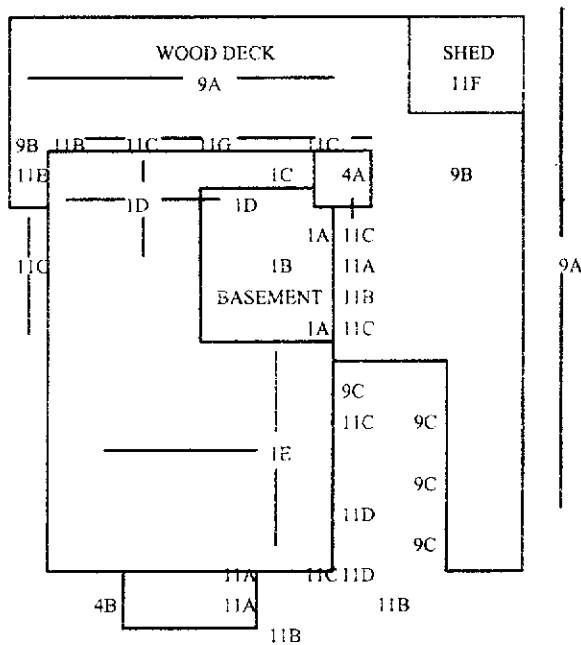
**DIAGRAM AND EXPLANATION OF FINDINGS (This report is limited to structure shown on diagram) Diagram not to scale**

- 1A Fungus (dry rot) damage was noted to the 2x4 wall studs and mud sill on the right side of the structure. See 1A on diagram.

- 1B Plumbing leak was noted beneath the kitchen sink. See 1B on diagram.

1C Fungus (dry rot) damage was noted to the 1x4 subfloor and 4x6 joist beneath the rear porch. See 1C on diagram.

1D Fungus growth noted to the subfloor beneath the laundry room. See 1D on diagram.

1E Portions of the subarea are inaccessible due to no access opening. See 1E on diagram.

4A Fungus (dry rot) damage was noted to the 2x12 stair jack and 2x6 steps at the rear wood porch. See 4A on diagram.

4B Earth-to-wood contact noted to the lattice on the left side of the front porch. See 4B on diagram.

9A Portions of the rear attached wood deck were noted to be inaccessible for inspection due to lack of clearance between the soil and wood members. See 9A on diagram.

9B Fungus (dry rot) damage was noted to approximately 40 lineal feet of 2x6 deck boards. See 9B on diagram.

9C Fungus (dry rot) damage was noted to approximately four 4x4 support posts and pads at the wood deck. See 9C on diagram.

11A Fungus (dry rot) damage was noted to the 1x4 soffits at the front porch and right side of the structure. See 11A on diagram.

11B Fungus (dry rot) damage was noted to the 1x6 fascia at the front, rear, and right side of the structure. See 11B on diagram.

11C Fungus (dry rot) damage was noted to approximately 140 lineal feet of 1x5 lap siding. See 11C on diagram.

11D Fungus (dry rot) damage was noted to the 1x3 corner trim at the front of the structure. See 11D on diagram.

11E Fungus (dry rot) damage was noted to the 1x3 left side window trim. See 11E on diagram.

11F Portions of detached wood shed were noted to be inaccessible for inspection due to storage. See 11F on diagram.

RECOMMENDATION: Remove and replace damaged wood members with new material and treat adjacent or exposed wood members with an approved chemical fungicide (COPPER NAPHTHENATE) to correct the above noted condition. ATTENTION: During the performance of repairs at the above mentioned areas, should any additional damage or conditions be found that were not visible or accessible at the time of the inspection without removing lumber or finished products, the owner or their representative will be contacted for direction.

RECOMMENDATION: Make necessary repairs to correct the above reported leak. ATTENTION: Treat adjacent wood members with an approved fungicide.

RECOMMENDATION: From the subarea, remove and replace visibly damaged wood members with new material and re-support as needed. Treat adjacent wood members with an approved chemical fungicide (COPPER NAPHTHENATE). ATTENTION: If damage cannot be fully removed from the subarea or extends into areas not accessible, a Supplemental Report will be issued on findings and owner or their representative will be contacted with additional costs.

RECOMMENDATION: Remove all visible surface fungus growth and apply an approved chemical fungicide (COPPER NAPHTHENATE) to infected area(s).

RECOMMENDATION: Install adequate sized permanent opening to gain access into area and issue a Supplemental Report on findings.

RECOMMENDATION: Remove and replace damaged stair jacks and/or steps with new material to correct the above noted condition. ATTENTION: During the performance of repairs at the above mentioned areas, should any additional damage or conditions be found that were not visible or accessible at the time of the inspection without removing lumber or finished products, the owner or their representative will be contacted for direction.

RECOMMENDATION: Lower soil away from wood members to correct earth-to-wood contact. ATTENTION: During the performance of repairs at the above mentioned areas, once the soil is lowered, if any additional damage or infestation is noted to wood members that was not visible or accessible at the time of inspection. A Supplemental Report will be issued on findings and owner or their representative will be contacted with additional cost.

RECOMMENDATION: Remove portions of decking to allow for inspection for wood members under deck and issue a Supplemental Report on findings. ATTENTION: During the performance of repairs at the above mentioned areas, should any additional damage or conditions be found that were not visible or accessible at the time of the inspection without removing lumber or finished products, the owner or their representative will be contacted for direction.

RECOMMENDATION: Remove and replace damaged wood decking with new material. ATTENTION: If damage exceeds specified footage or any additional damage is found a Supplemental Report will be issued on findings and owner or their representative will be contacted with additional costs. ATTENTION: During the performance of repairs at the above mentioned areas, should any additional damage or conditions be found that were not visible or accessible at the time of the inspection without removing lumber or finished products, the owner or their representative will be contacted for direction.

RECOMMENDATION: Remove and replace damaged wood members with new material and treat adjacent or exposed wood members with an approved chemical fungicide (COPPER NAPHTHENATE) to correct the above noted condition. ATTENTION: Application of caulking or sealant is considered a normal homeowner repair and MILLENNIUM TERMITE will not guarantee against future leaks of this type.

RECOMMENDATION: Remove the damaged 1x4 enclosed soffit(s). Inspect wood members for additional damage and treat with an approved chemical fungicide (DISODIUM, OCTABORATE and TETRAHYDRATE SOLUTION). Reinstall new soffit(s) to match as close as possible. ATTENTION: If additional damage is found, a Supplemental Report will be issued on findings and owner or their representative will be contacted with additional costs. ATTENTION: Application of caulking or sealant is considered a normal homeowner repair and MILLENNIUM TERMITE will not guarantee against future leaks of this type.

RECOMMENDATION: Remove and replace approximately 140 lineal feet of damaged siding with new to match existing as close as possible. ATTENTION: If additional damage is found a Supplemental Report will be issued on findings and owner or their representative will be contacted with additional costs. ATTENTION: MILLENNIUM TERMITE is not responsible for any texture or painting that may be necessary.

RECOMMENDATION: Remove storage away from wall to allow for further inspection.
