Site Address: 2830 27TH ST SAC

Nature of Work: RELEVEL EXISTING HOMEBUILD NEW CRIPPLE WALLS

Re **Investigation of Settlement Distress - Repair Specifications Report, Revised**  
Insured: Ron and Judith Paulet  
Claim Number: 02-042-6767  
Date of Loss: 01/10/98  
Address: 2830 27th Street, Sacramento, CA 95818  
Date of Assignment: 03/13/98  
Date of Inspection: 03/24/98  
Our File Number: 980343

REPAIR PLAN - REVISED

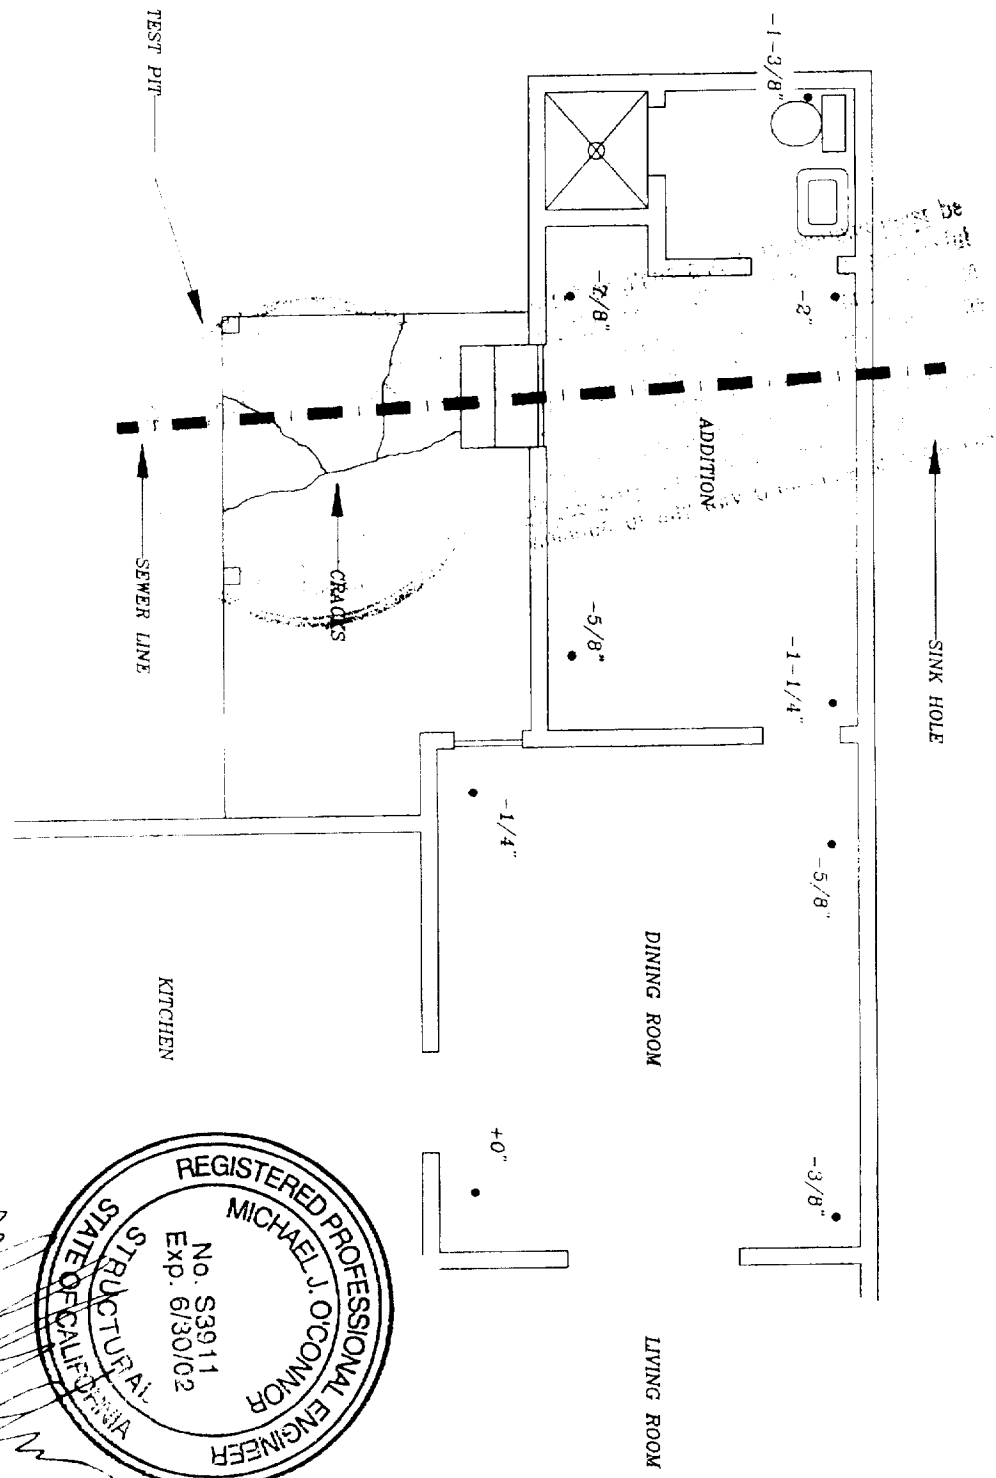
I used a water-filled manometer to conduct a level survey of the affected area of the house. The level survey showed that the room addition and the covered patio had settled downward. The amount of settlement was approximately 1 5/8 inches as compared to the dining room of the original house. It was clear that this downward movement was causing the distress to the footing, the distress to the hardwood floor, the distress to the corner of the room addition bathroom, and the distress to the brick veneer at the northwest corner.

• Indicates The  
 Floor Elevation  
 Is 3/4" Below  
 High Spot
