Site Address: 39 SAGE RIVER CR SAC

Nature of Work: TEAR OFF, RESHEET & REEOF 40 SQ LT WT TILE FOR SFR

re: Job 2003211: TSUI

Subject: Structural Investigation Report of the Roof for the Residence located at 39 Sage River Circle, Sacramento, CA 95831.

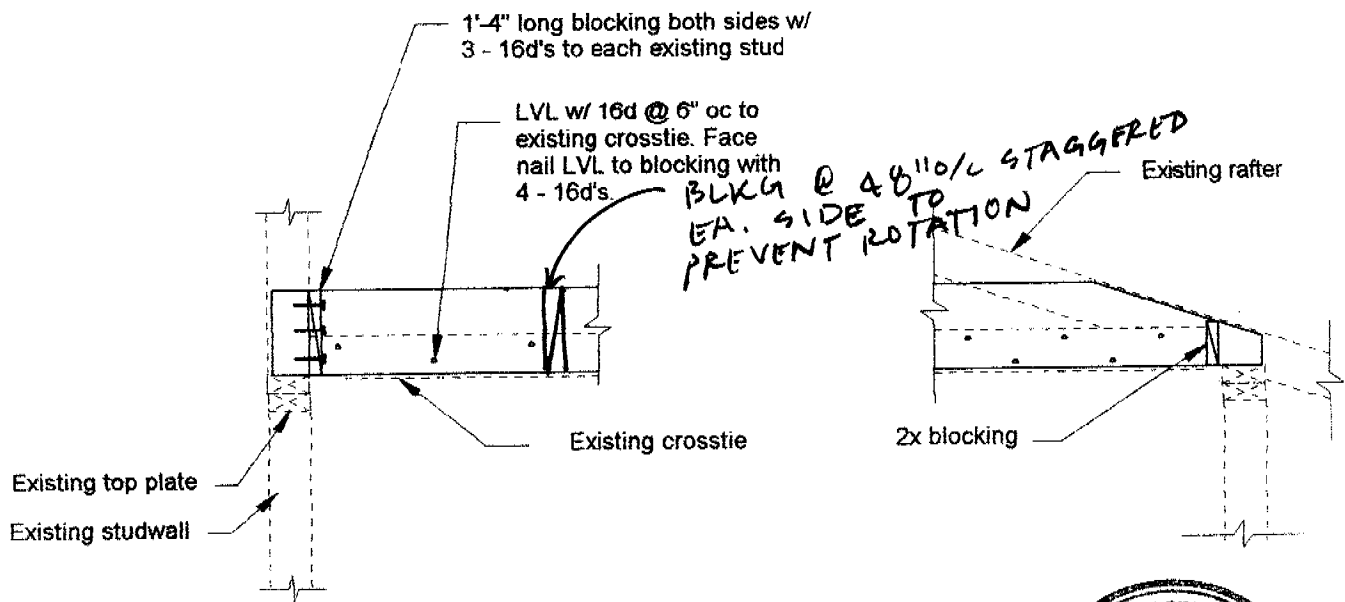
1 ROOF PLAN - TSUI
Not to Scale

The roof structure currently lacks sufficient structural capacity for the applied live and dead loads. See "Recommendations" for location and repair to bring the roof structure up to the required capacity.

1. Add 2x4 struts to bearing below (total 2).
2. Scab a 1-3/4" x 11-7/8" LVL to the existing 2x6 crossie with 16d's @ 6" oc. The ends of the LVL may be clipped as required to meet the slope of the rafters. Support the LVL on the existing double top plate. Support the existing ridge, hip and valley rafters to the LVL below with 2x4 struts. See detail 2.
3. Double the 2x6 rafters on each side of the existing skylight. Nail the rafters together with 16d's @ 12" on center. (total 4 rafters at 2 locations).

1. Provide additional 2x4 struts from the existing purlins to the bearing walls below. The maximum spacing between the new and existing struts shall not exceed 6'-0" on center. The unbraced length of the struts shall not exceed 8'-0" and the minimum slope of the struts shall not be less than 45 degrees from the horizontal. See detail 1.
2. Scab a 1 3/4" x 11 7/8" LVL beam to the existing 2x6 crosstie and nail together with 16d's @ 6" oc. The ends of the LVL may be clipped as required to meet the slope of the rafters. Support the LVL on the existing double top plate. Support the existing hip, valley and ridge to the LVL beam with 2x4 struts. See details 1 and 2.
3. Double the 2x6 rafters on each side of the existing skylight. Nail the rafters together with 16d's @ 12" on center. See detail 1.
