of Work: DRY ROT REPAIRS TROUGHOUT HOUSE PER TERMITE REPORT

WOOD DESTROYING PESTS AND ORGANISMS INSPECTION REPORT

ADDRESS OF PRO	PERTY INSPECTED			and the state of the state of		
BUILDING NO.	STREET	Ċ	TY	21P	COOPTY	INSPECTION	HUMBER C	JF
7025	TAMOSHANTER WAY	2	SACRAMENTO	95822	34	01/10/01	6

MITCHELL HALL TERMITE CONTROL

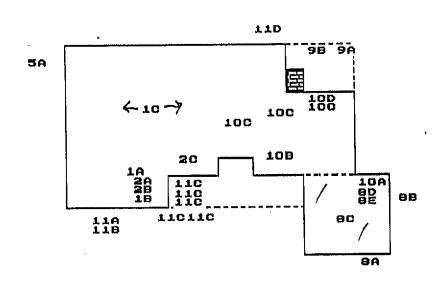
Item 11D: FINDING: WOOD DECAY FUNGI DAMAGE WAS FOUND IN THE EAVES OF THE STRUCTURE AS DESIGNATED -11D- ON THE DIAGRAM.

RECOMMENDATION: REMOVE AND REPLACE THE DAMAGED WOOD MEMBERS WITH NEW WOOD. APPY DISODIUM OCTABORATE TETRAHYDRATE (TIM-BOR) TO THE AREAS OF REPAIR TO INHIBIT THE FURTHER GROWIH OF WOOD DECAY FUNGI. NOTE: DURING THE COURSE OF THIS REPAIR, THE ROOF COVERING WILL BE DISTURBED. IT IS THE RESPONSIBILITY OF THE QUARR OF THE STRUCTURE TO CONTACT A LICENSED ROOFING CONTRACTOR TO MAKE ANY REPAIRS TO THE ROOF COVERING SYSTEM.
