Permit No: 9715111
Insp Area: 2

Nature of Work: TERMITE REPAIR PER LIST

WOOD DESTROYING PESTS AND ORGANISMS INSPECTION REPORT

BUILDING NO. 1933	STREET WAKSFIELD WAY	CITY SACRAMENTO	ZIP 95822	COUNTY CODE 34	DATE OF INSPECTION 06/17/97	NUMBER OF PAGES 7
----------------------	-------------------------	--------------------	--------------	-------------------	--------------------------------	----------------------

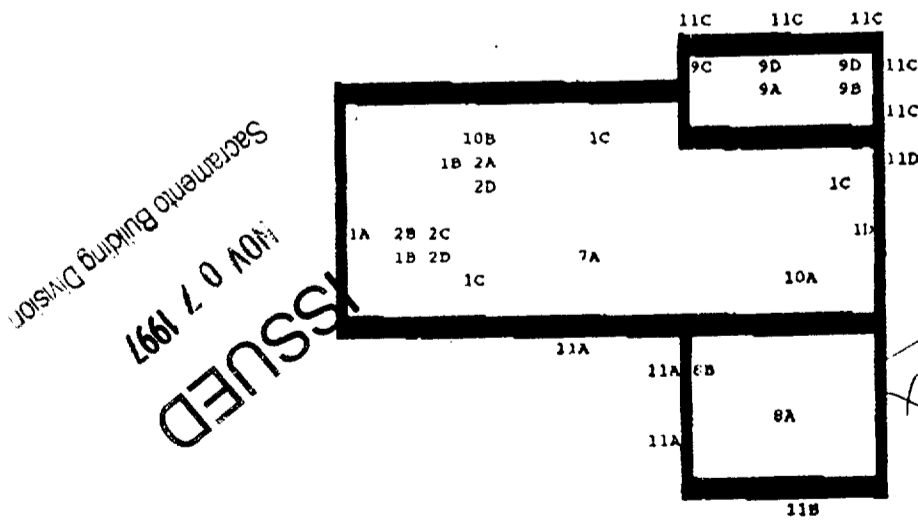
DIAGRAM AND EXPLANATION OF FINDINGS (This report is limited to structure or structures shown on diagram)

1. SUBSTRUCTURE AREA - Dry. 1A- 1D			X
2. STALL SHOWER - Tested=Yes, floors=Bad. 2A- 2D			X X
3. FOUNDATIONS - Concrete.			
4. PORCHES - STEPS - Concrete.

5. VENTILATION - Appears Adequate.			
6. ABUTMENTS - None.			
7. ATTIC SPACES - Partial Access, Insulated. 7A		X	
8. GARAGES - Attached, Partial Access. 8A- 8B		X	X

9. DECKS - PATIOS - Attached. 9A- 9C		X	X
10. OTHER - INTERIOR 10A-10B			X
11. OTHER - EXTERIOR 11A-11D

FINDING: Evidence of FUNGUS (DRY ROT) located AT CRAWL ENTRY FRAMING

FINDING: Evidence of FUNGUS (DRY ROT) located IN SUBFLOOR AND GIRDERS UNDER BOTH BATHROOM FLOORS (PRICE AND RECOMMENDATION IN 2D)

FINDING: CELLULOSE DEBRIS noted as 1C on the diagram.

FINDING: Evidence of FUNGUS (DRY ROT) located UNDER KITCHEN SINK.

FINDING: Caulk loose and/or missing and is located IN MASTER BATH SHOWER FLOOR, (RECOMMENDATION AND PRICE IN 2D)

FINDING: Toilet(s) loose noted as 2B on diagram.

FINDING: Caulk loose and/or missing and is located IN HALL BATH TUB ENCLOSURE

FINDING: FUNGUS DAMAGE TO SUBFLOOR UNDER BOTH BATHROOMS CONFIRMED BY TRAMEX MOISTURE READINGS. ***

FINDING: Deep insulation prevented us from entering the attic and it is noted as an inaccessible area, 7A on the diagram. Our inspection, as permitted from the access opening, revealed no adverse conditions unless stated in this report.

FINDING: Areas of the structure were INACCESSIBLE due to STORAGE

FUNGUS DAMAGE TO 2X6 CENTER MATCH ROOM DECKING. *** **

THE WOODEN FLOOR IS INACCESSIBLE TO INSPECTION OF THE UNDERSIDE AND IT IS IMPOSSIBLE TO DETERMINE THE FOUNDATION STRUCTURE. EXCESSIVE MOISTURE READINGS WERE RECORDED WITH MOISTURE METER-DAMAGE IS POSSIBLE.

Evidence of FUNGUS (DRY ROT) located WINDOW SILL

Grout loose and/or missing and is located ON KITCHEN COUNTER AT SINK.

HARDWOOD FLOOR IN MASTER BEDROOM IS BUCKLED, STAINED AND FUNGUS DAMAGED. ***

Evidence of FUNGUS (DRY ROT) located in -
PLANTER SHELF & WINDOW SILL

GUTTERS ARE RUSTED

Evidence of FUNGUS (DRY ROT) located in - GIRDERS AND SHEATHING

Evidence of FUNGUS (DRY ROT) located in - BARGE RAFTER AND FASCIA.

RECOMMENDATION: Remove cellulose debris.

RECOMMENDATION: Correct loose toilet(s) .

RECOMMENDATION: Remove the bottom two rows of the shower tiles and entire shower pan. Install a new subdrain, three layer hot mop pan and new tile over mortar.

RECOMMENDATION: REMOVE BOTH BATHROOM TILE FLOORS AND REPAIR DAMAGED SUBFLOOR AND GIRDERS. REINSTALL NEW UNDERLAYMENT AND LINOLEUM; RESET THE TOILETS ON A WAX RING. REPAIR DAMAGED SUBFLOOR UNDER TUB AND BEDROOM CLOSET.

REMOVE DAMAGED DECKING, REDUCE DECKING OVERHANG AND RE-ROOF WITH NEW ROLL ROOFING.

OPEN FOR FURTHER INSPECTION

REPLACE DAMAGED HARDWOOD FLOORING. *** **
