Site Address: 2620 MARSHALL WY SAC

Nature of Work: STUCCO/WOOD TRIM DRY ROT REPAIR & RPLC FLOORING IN L ROOM AND BATH/NEW FRAMING

WOOD DESTROYING PESTS AND ORGANISMS INSPECTION REPORT

REGISTRATION # PR 2488	REPORT # 24882A	STAMP #	ESCROW #
---------------------------	--------------------	---------	----------

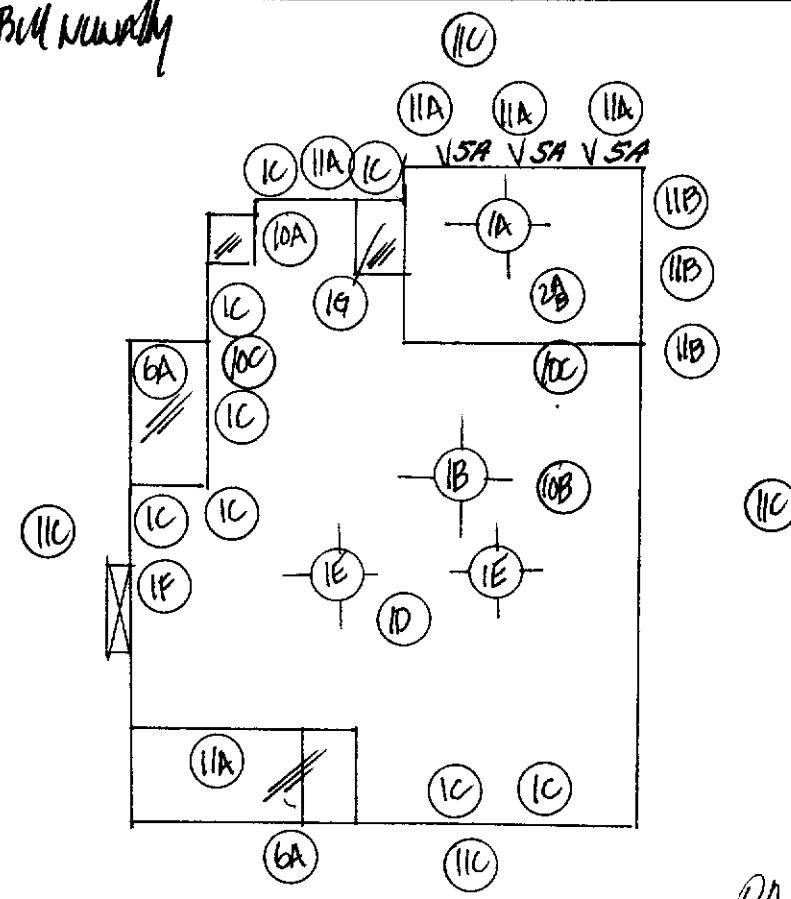
DIAGRAM AND EXPLANATION OF FINDINGS (This report is limited to structure or structures shown on diagram)

Item 1B: FINDING: CELLULOSE DEBRIS (WOOD SCRAPS) WERE NOTED OVER THE SUBAREA SOIL. THIS CONDITION IS CONDUSIVE TO WOOD DESTROYING PEST AND ORGANISMS. SEE 1B ON DIAGRAM.

Item 1C: FINDING: CRACKS AND/OR OPEN VOIDS WERE FOUND IN THE STUCCO AND WOOD DECAY FUNGI HAS DAMAGED THE SILLS, FRAMES, SHEATHING AND VENTS. SEE ITEM 1C ON DIAGRAM.

Item 1D: FINDING: A PLUMBING LEAK WAS FOUND AT THE COPPER WATER LINE. SEE ITEM 1D ON DIAGRAM.

Item 1E: FINDING: WOOD DECAY FUNGI HAS DAMAGED THE PIER PADS AND EARTH TO WOOD CONTACT WERE ALSO FOUND AT THE PIERS. SEE ITEM 1E ON DIAGRAM.

Item 1F: FINDING: WOOD DECAY FUNGI HAS DAMAGED THE SILLS AND/OR FRAME ADJACENT TO THE FIREPLACE. SEE ITEM 11F ON DIAGRAM.

Item 1G: FINDING: WOOD DECAY FUNGI HAS DAMAGED THE BASEMENT STAIRS. SEE ITEM 1G ON DIAGRAM.

Item 10A: FINDING: WOOD DECAY FUNGI HAS DAMAGED THE SUBFLOOR, UNDERLAYMENT, DOOR, MOLDING AND CASING OF THE LAUNDRY ROOM. SEE ITEM 10A ON DIAGRAM.

Item 10B: FINDING: EXCESSIVE MOISTURE DAMAGE NOTED TO THE UNDERLAYMENT ADJACENT TO THE SHOWER PAN AND TOILET AT THE FRONT HALL BATHROOM. SEE ITEM 10B ON DIAGRAM.

Item 10C: FINDING: WOOD DECAY FUNGI HAS DAMAGED THE FALSE BOTTOMS OF THE KITCHEN AND REAR BATHROOM VANITIES. SEE ITEM 10C ON DIAGRAM.

Item 11A: FINDING: CRACKS AND/OR OPEN VOIDS WERE FOUND IN THE STUCCO. WOOD DECAY FUNGI HAS DAMAGED THE WINDOW STUCCO MOLDINGS, TRIMS, CASINGS AND SILLS. SEE ITEM 11A ON DIAGRAM.

Item 11B: FINDING: WOOD DECAY FUNGI HAS DAMAGED THE LX AT THE WATER STAINED SOFFITS. SEE ITEM 11B ON DIAGRAM.

Item 11C: FINDING: OPEN VOIDS AND/OR CRACKS WERE FOUND IN THE STUCCO AT VARIOUS AREAS OF THE STRUCTURE. SEE ITEM 11C ON DIAGRAM.

Item 2A: FINDING: THE STALL SHOWER COULD NOT BE TESTED TO DETERMINE IF THE SHOWER LEAKS DUE TO THE SUBAREA BELOW BEING INACCESSIBLE AS PER ITEM 1A. SEE ITEM 2A ON DIAGRAM.

Item 2B: FINDING: THE PLUMBING BEHIND THE STALL SHOWER TILE WALL COVERINGS ARE LOOSE AS THE SHOWER HEAD, VALVE STEMS AND HANDLES MOVE. SEE ITEM 2B ON DIAGRAM.

Item 5A: FINDING: WOOD DECAY FUNGI HAS DAMAGED THE VENTS, FRAMES AND SUBAREA WOOD MEMBERS. THIS APPEARS TO HAVE BEEN CAUSED BY INADEQUATE VENTILATION AND MOISTURE ENTERING THE VOIDS BETWEEN THE STUCCO AND DAMAGED VENTS AND FRAMES. CRACKS AND/OR VOIDS WERE ALSO FOUND IN THE STUCCO. SEE ITEM 5A ON DIAGRAM.

Item 6A: FINDING: THE STUCCO COLUMNS AND/OR ABUTMENTS ARE UNVENTED AND THEY APPEAR TO BE SETTLING ON A CONCRETE FOOTING. SEE ITEM 6A ON DIAGRAM.

RECOMMENDATION: REMOVE AND DISPOSE OF ALL CELLULOSE DEBRIS OF A RAKEABLE SIZE OR LARGER TO CORRECT ABOVE CONDITION.

RECOMMENDATION: REMOVE THE STUCCO. REMOVE AND REPLACE THE DAMAGED WOOD MEMBERS AND RE-STUCCO THE AREAS OF REPAIRS. INSTALL 1/4" MESH WIRE VENTS. SEE V ON DIAGRAM.

RECOMMENDATION: OTHER TRADES TO REPAIR THE LEAK.

RECOMMENDATION: REMOVE AND REPLACE THE DAMAGED PIER PADS WITH PRESSURE TREATED SILLS AND/OR CONCRETE PADS.

RECOMMENDATION: REMOVE THE STUCCO AND REMOVE AND REPLACE THE DAMAGED SILLS, SHEATHING AND FRAMES. RE-STUCCO THE AREAS OF REPAIR.

RECOMMENDATION: REMOVE THE STAIRS AND REPLACE THE STAIRS WITH PRESURE TREATED MATERIALS.

RECOMMENDATION: REMOVE AND REPLACE THE DAMAGED MOLDING, CASING, FLOOR COVERING, UNDERLAYMENT AND SUBFLOOR. INSTALL NEW DOOR TRIM AND CASING AND SEAL THE DOOR TRIMS. INSTALL NEW SUBFLOOR, UNDERLAYMENT AND FINISHED FLOOR COVERINGS IN LAUNDRY ROOM ONLY.

RECOMMENDATION: REMOVE THE TOILET, VINYL FLOOR COVERING AND UNDERLAYMENT COMPLETELY. IF DAMAGE EXTENDS INTO AREAS NOT VISIBLE, A SUPPLEMENTAL REPORT WILL BE FILED. INSTALL NEW UNDERLAYMENT AND FLAT LAY VINYL FLOOR COVERING WITH RUBBER BASE. RE-INSTALL TOILET ON A NEW WAX SEAL.

RECOMMENDATION: REMOVE AND REPLACE THE DAMAGED PORTIONS OF THE CABINETS.

RECOMMENDATION: REMOVE AND REPLACE THE DAMAGED WOOD MEMBERS. SEAL THE CRACKS AND/OR VOIDS WITH STUCCO PATCH AND EXTERIOR GRADE SEALANT.

RECOMMENDATION: REMOVE AND REPLACE THE DAMAGED WOOD MEMBERS WITH NEW MATERIALS. PRIME PAINT TO MATCH.

RECOMMENDATION: OWNER TO HAVE THE VOIDS AND/OR CRACKES PATCHED AND/OR SEALED AS NEEDED. OWNER TO MAINTAIN IN THE FUTURE.

RECOMMENDATION: AFTER SUBAREA IS MADE ACCESSIBLE, NORTH AMERICAN TERMITE & PEST CONTROL WILL WATER TEST THE STALL SHOWER. A SUPPLEMENTAL REPORT WILL BE ISSUED OUTLINING ANY FINDINGS OR RECOMMENDATIONS IF NECESSARY.

RECOMMENDATION: OWNER TO CONTACT A LICENSED PLUMBER TO REPAIR THE PLUMBING AND SEAL AS NEEDED.

RECOMMENDATION: REMOVE THE STUCCO. REMOVE AND REPLACE THE DAMAGED WOOD MEMBERS AT THE VENTS AND INSTALL ADDITIONAL VENTS WHERE INDICATED BY THE V ON THE DIAGRAM. RE-STUCCO THE AREAS OF REPAIR.

RECOMMENDATION: INSTALL VENTS AT THE COLUMNS.
