Nature of Work: FIRE REPAIR IN LAUNDRY ROOM TO REPLACE STRUCT. ELEMENTS
LIKE FOR LIKE, ELECTR. AND PLUMB. NO EXTERIOR WORK

Sacramento Fire Department - Incident Report

Re: Walker House Repair
2141 2nd Avenue, Sacramento, CA 95818
EFI Job Number: 94605-24171

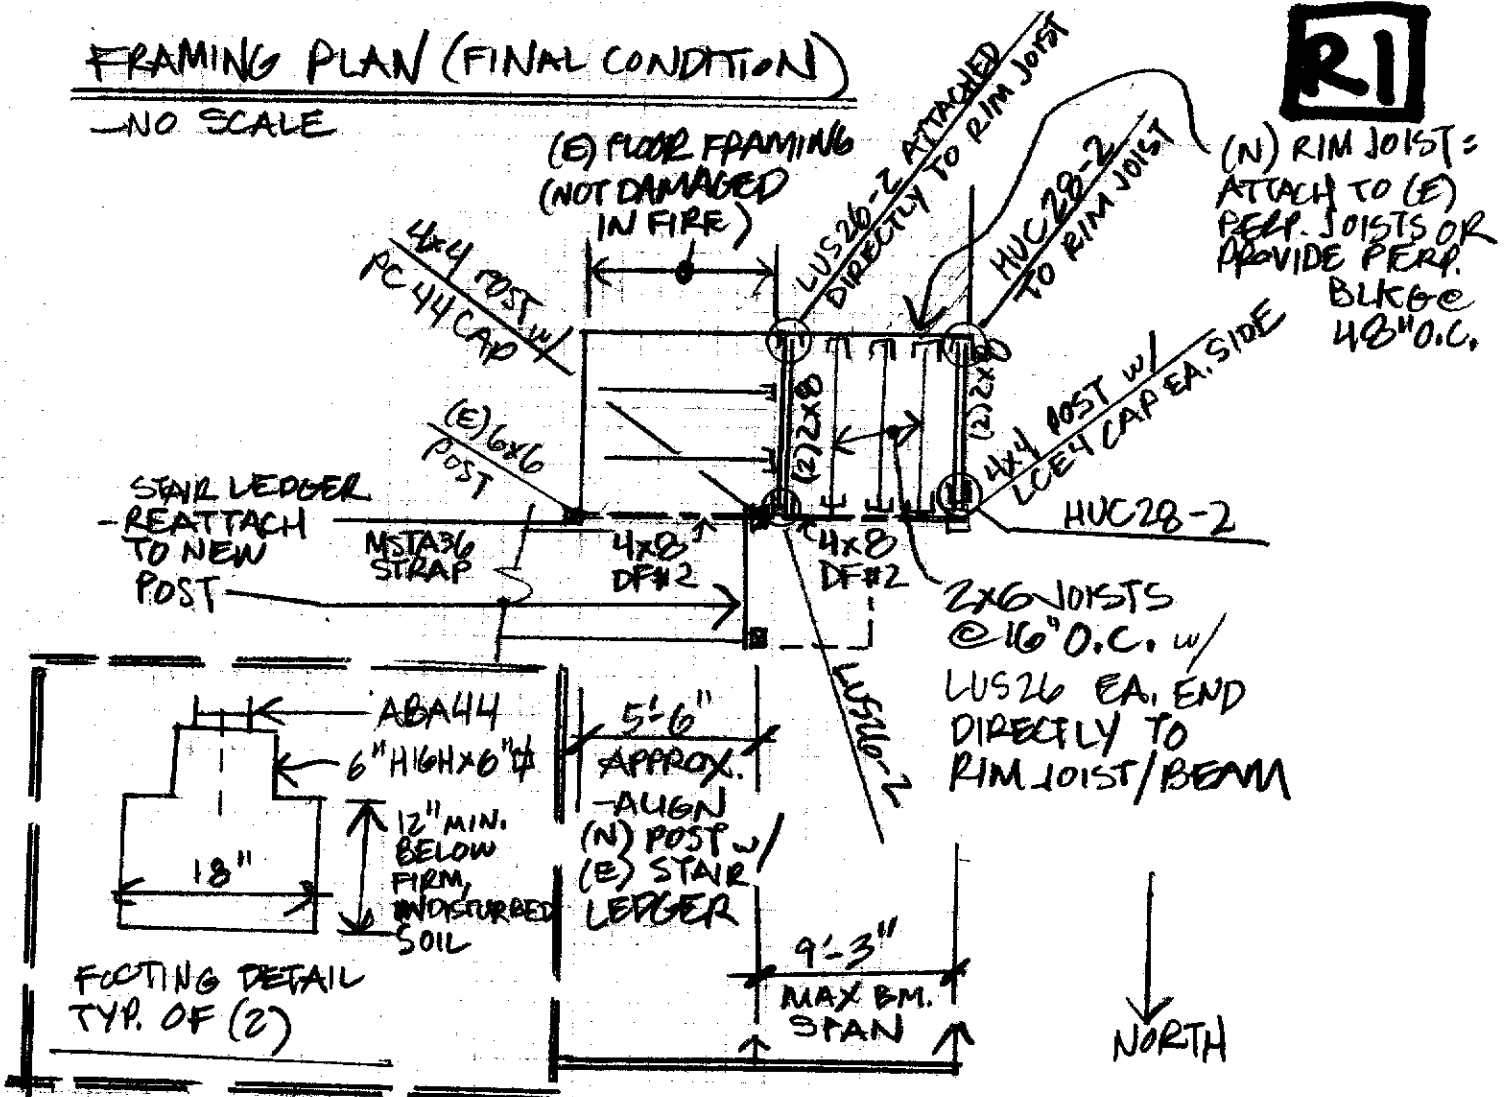
FRAMING PLAN (FINAL CONDITION)

The framing at the overhanging 2nd floor at the rear of the house was questionable in general; there were defective connections and framing. The framing that had been damaged by the fire had already been removed and the walls were temporarily shored. After review, we have provided a partial framing plan sketch at the subject area. Please see the attached sketch (sheet R1). The first phase is to replace the beam along the rear, provide a double joist to support the west wall, and provide a diagonal beam to span over the tank and support the corner. Once this is complete, the work on the septic tank can begin.

Please note that the intent of the framing plan provided is to repair the 2nd floor framing damaged by the fire and slightly improve the existing condition of the adjoining framing, not to make this portion of the house perfect. Preexisting rot damage, termite damage, architectural, electrical, mechanical, and other repairs or improvements are outside the scope of our services. Therefore, there may be adverse pre-existing conditions not covered in this package that are outside of our responsibility to show requirements for repairing the fire damage.

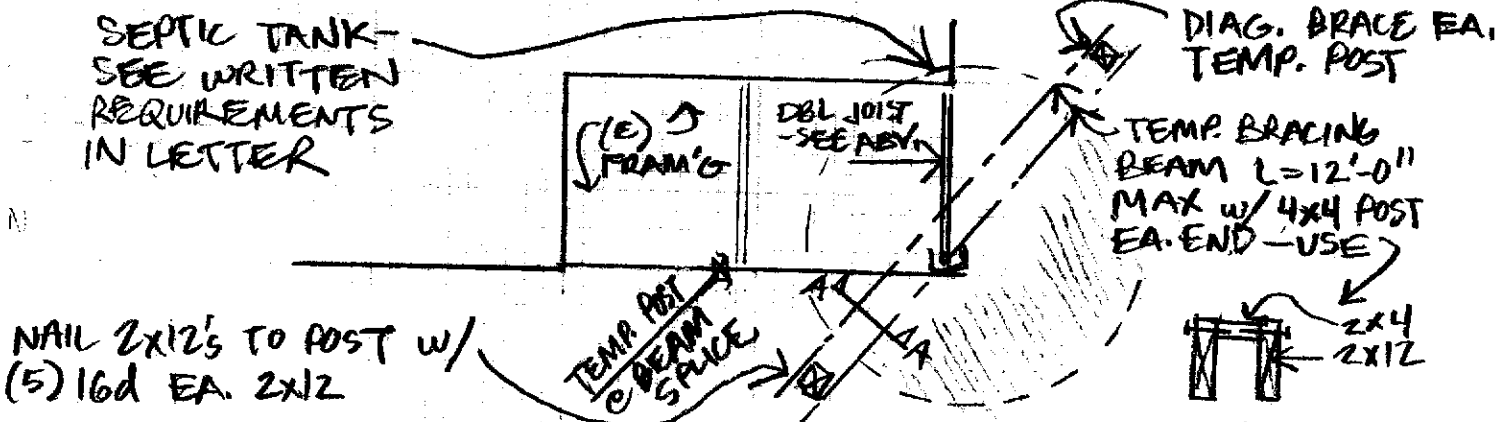
FRAMING PLAN (TO DO BEFORE ADDRESSING SEPTIC TANK)

We met with you at the site on April 2, 2002. The septic tank was a dome-shaped brick tank, and the top was approximately one to two feet below the soil surface. The exact depth of the tank was unknown. There was water and loose/muddy soil in the tank and a total of six pipes entering the tank. Most of the water was entering the tank from one of the pipes at the rear of the house. It was clear that there was a leaking sewer line in the vicinity as evidenced by waste water that had leaked into a hole excavated for the intermediate post footing. Also, it appeared that the perimeter house footing slightly overlapped the underlying edge of the tank.

- [1] Temporarily brace the second floor walls with the diagonal beam and other components shown on the attached sketch (sheet R1). Please note that the beam orientation does not matter, provided that the temporary beam supports the end of the new beam as shown. Also, if desired, the joist framing at the 2nd floor can be done prior to filling the septic tank provided that the diagonal beam stays in place.

NAIL 2x12's TO POST w/ (5) 16d EA. 2x12
