Site Address: 2017 51ST ST SAC  
Parcel No: 011-0141-030

Nature of Work: TERMITE AND DRY ROT REPAIR AS PER REPORT IN FOLDER.

# WOOD DESTROYING PESTS AND ORGANISMS INSPECTION REPORT

BUILDING NO.	STREET	CITY	ZIP	COUNTY CODE	DATE OF INSPECTION	NUMBER OF PAGES
2017	51ST ST	SACRAMENTO	95817	34	04/12/01	4

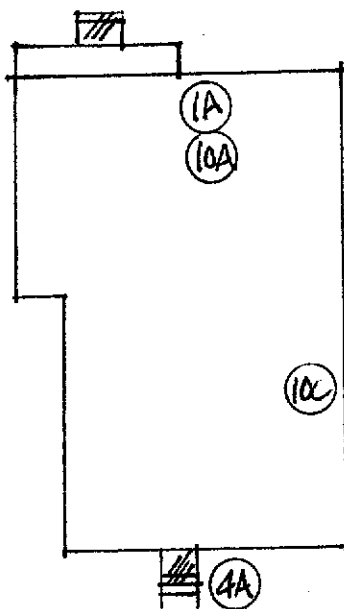
Item 1A: A portion of the subarea was not inspected due to standing water. Further inspection is recommended after the water recedes. Render a supplemental report on findings.

Item 4A: Wood decay fungi has infected and damaged the plywood at the front porch. Remove and replace 3 square feet of plywood.

Item 10A: The tiles are cracked and open voids in the tiles above the tub. Seal the open voids and cracks with a moisture proof compound.

Item 10B: A leak at the commode has damaged the floor covering adjacent the commode. Remove the commode, damaged underlayment and floor covering and reset the commode on a new wax ring.

Item 10C: Wood decay fungi has infected and damaged the window casing. Remove and replace the damaged portion of the casing.

NOTE: Portions of the exterior wood members are noted to be weathered and worn. No adverse conditions noted. Periodic inspection is recommended.

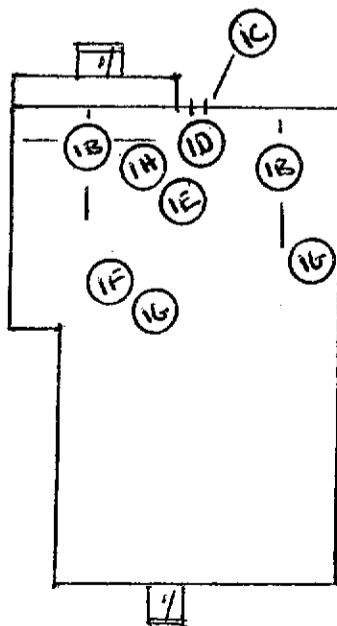
Item 1B: Evidence of subterranean termites noted at subarea. Treat the following areas with a registered termiticide for the control of subterranean termites. Trench and treat the subarea foundation, piers, and plumbing accesses. Drill and treat porches abutting the exterior foundation. Seal holes with mortar. Treat exterior soil by either rodding or trenching.

Item 1C: Fungus and termite damaged wood noted at subaccess. The damage appears to be in the exterior sheathing and extends into inaccessible areas. Remove approximately six square feet of stucco for further inspection. If damage does not extend beyond this area, make necessary repairs and refinish stucco.

Item 1D: Fungus and termite damage noted in the subarea under the bathroom floor. The damage is in the subflooring and floor joist and extends into inaccessible areas. The fungus damage appears to be caused by a leaking toilet in the above bathroom. Remove and replace damaged wood members as needed. If the damage extends beyond the perimeter of the bathroom the estimate will be revised.

Item 1E: Fungus damaged wood noted at plywood subflooring under bathtub. The damage appears to be caused by the oversplash of the tub. Remove and replace the underlayment, floor coverings and sub-flooring in the bathroom. As noted earlier if the damage extends beyond the bathroom perimeters, a supplemental report will be issued and price revised.

- Item 1F: Fungus damaged wood noted at 3x6 plate on cross foundation of the subarea. Moisture source causing the damage was undetectable to the inspector at this time. Remove and replace twelve lineal feet of lumber and replace with new material.
- Item 1G: Earth to wood contacts noted at pier supports in the subarea. Lower soil at piers to correct condition.
- Item 1H: Plumbing leak noted at commode. ZAP will reset the commode when the floor is replaced. We will use a new wax ring but we are unsure if this will correct the condition. We recommend a licensed plumber be contacted to make necessary repairs.
