**CITY OF SACRAMENTO**  
1231 I Street, Sacramento, CA 95814

**Nature of Work: TERMITE REPAIR**

# WOOD DESTROYING PEST AND ORGANISMS INSPECTION REPORT

BUILDING NO. <b>3040</b>	STREET <b>44th Street</b>	CITY <b>Sacramento, CA</b>	ZIP <b>95817</b>	COUNTY CODE <b>34</b>	DATE OF INSPECTION <b>Jun 28, 2000</b>	No of Pages <b>4</b>
-----------------------------	------------------------------	-------------------------------	---------------------	--------------------------	---	-------------------------

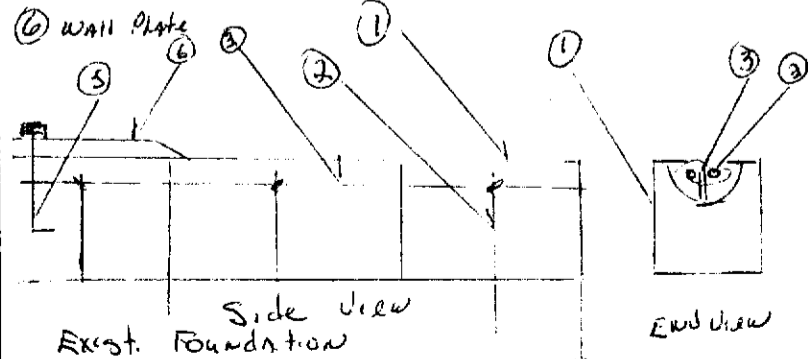
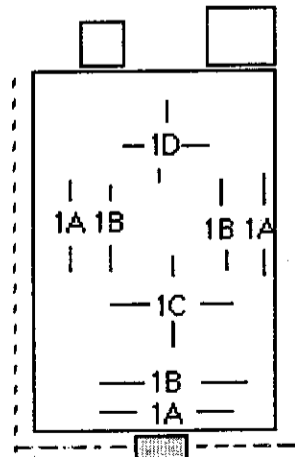
DIAGRAM AND EXPLANATION OF FINDINGS (This report is limited to structure or structures shown on diagram)

FINDING #1A: The brick foundation is deteriorating.

FINDING #1B: Wood decay fungi and wood boring beetle damage to mudsill cripple wall foundation and back side of siding.

FINDING #1C: Water in the subarea is condensing on the wood members.

FINDING #1D: Wood Destroying Beetles are infesting the structure in the subarea.

- ① 8x8x16" Concrete Block (Benmark)
- ② 1/2" Rebar Drilled into Foundation and Spaced Vertically 32" @
- ③ 2 Strands of 1/2" Rebar Running Continuously Inside Beam Block and 2' Around Corners, Tied to Verticals.
- ④ Each Block to Set in 1/2" Mortar Bed
- ⑤ Each Block to Be Jointed by 1/2" Mortar Joint
- ⑥ 1/2"x7" Anchor Bolts to Be Placed within one foot of ends and 6" @ of wall posts

RECOMMENDATION: Remove and replace brick foundation with a concrete cinder block foundation. Install an approved concrete foundation under the walls where indicated by a broken line on diagram. Precautions will be taken; however, we cannot accept responsibility for cracks due to vibration caused by our work or earth settling after completion.

RECOMMENDATION: Remove up to two hundred square feet of mudsill cripple wall foundation and back side of siding to permit our State licensed inspector to determine the extent of the damage. Inject TIMBOR at 20 p.s.i. We will then list needed repairs and any additional costs in a supplemental report. If no further damage is found, Clark Pest Control will install new wood.

RECOMMENDATION: Install an impervious membrane on the soil to retard condensation. In the event that this measure does not completely control the evaporation of the percolating ground water, the owner should employ a consulting engineer to make recommendations for permanent corrective measures.

RECOMMENDATION: Seal the entire structure and fumigate it with METHYL BROMIDE. Use Chloropicrin (tear gas) as a warning agent. The structure must be vacated and aired out for a minimum of 120 hours after tarps are removed, depending on weather conditions and temperature. We will use all due caution while performing our work; however, we assume no liability for any damage to roof coverings, solar panels, antennas, or vegetation adjacent to the structure. Occupants must sign the "Occupants Fumigation Notice" and comply with all instructions. Owners and occupants must sign and receive copies of the CalEPA Department of Pesticide Regulation Fact Sheet regarding METHYL BROMIDE. WE WILL RETURN IN APPROXIMATELY ONE YEAR TO INSPECT THE STRUCTURE. IF WE FIND EVIDENCE OF REINFESTATION, WE WILL RETREAT THE AREA AT NO ADDITIONAL COST. AFTER ONE YEAR, THE STRUCTURE MAY BECOME ELIGIBLE FOR OUR PROACTIVE TERM-ALERT™ PROTECTION PROGRAM.
