Permit No: 9805229

Nature of Work: TERMITE AND DRYROT

WOOD DESTROYING PESTS AND ORGANISMS INSPECTION REPORT

BUILDING NO. 643	STREET 55TH ST.	CITY SACRAMENTO	ZIP 95819	COUNTY CODE 34	DATE OF INSPECTION 05/20/98	NUMBER OF PAGES 6
---------------------	--------------------	--------------------	--------------	-------------------	--------------------------------	----------------------

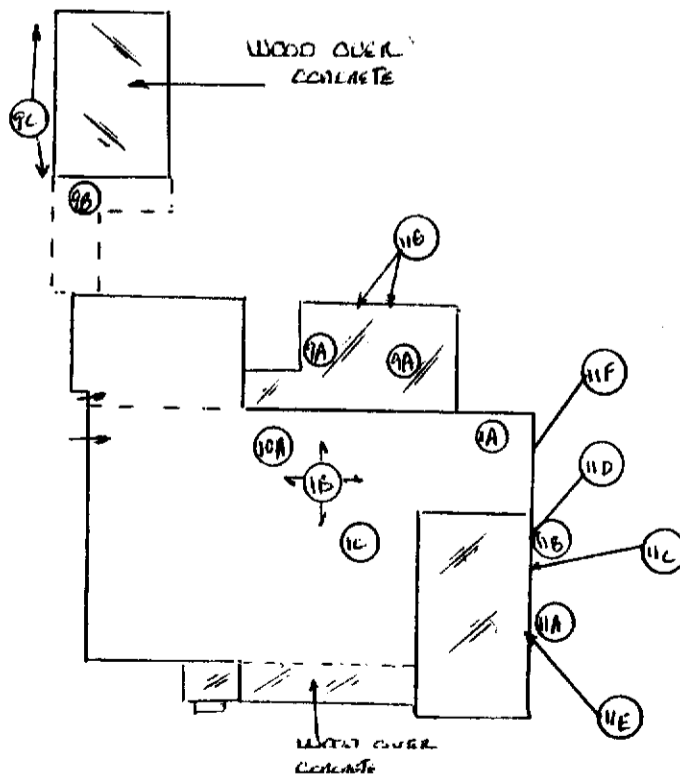
DIAGRAM AND EXPLANATION OF FINDINGS (This report is limited to structure or structures shown on diagram)

- Item 1A: A minor amount of subterranean termite damage was noted to the rim joist in the area marked 1A on diagram. Reinforce damaged area with new material.
- Item 1B: A minor amount of cellulose debris was scattered about the subarea soil. Remove cellulose debris of a rakeable size or larger.
- Item 1C: For the control of subterranean termites chemically treat the subarea soil according to label directions around foundation, piers, plumbing and infested soil. Drill holes through the concrete garage slab adjacent to the walls. Chemically treat soil and seal holes. Drill holes through the concret porch caps, walkways adjacent to foundation and patio slab. Chemically treat soil below and seal holes. Probe and or rod treat the exterior soil around the perimeter of the building.

- Item 9A: Fungus infection and damage was found to the 1x8 roof sheathing within the patio area marked 9A on diagram. Remove and remove approx. 40 lineal feet of 1x8 roof sheathing to correct this condition. NOTE: The roof material above this area was noted to be corrugated tin. The reinstallation of the corrugated tin is not included in this bid.

Item 9C: The area marked 9C on diagram was inaccessible for inspection due to access into the neighbors yard. If permission is granted further inspection would be performed upon request and a supplemental report would be issued outlining findings and a price quote for necessary repairs. NOTE: The wood fence is not included in this report.

- Item 11F: Fungus infection and damage was found to the wood trim and plywood covering over a decorative box marked 11F on the diagram. Remove and replace damaged material as necessary. Damage may be present in inaccessible areas. During the course of repairs if damage is found in interior wall framing such will be outlined on a supplemental report.

- Item 11G: Fungus infection and damage was found to the base of the 4x4 support post and door jamb marked 11G on diagram. Trim off the bottom of the post and resupport over a elevated metal post holder. Cut the base of the door jamb off and pack void with mortar.
