CITY OF SACRAMENTO

Permit No: 9807231

Nature of Work: BUSTER / REHAB GARAGE W/OUT PERMIT, QUAD FEE

# WOOD DESTROYING PESTS AND ORGANISMS IN DETECTION REPORT

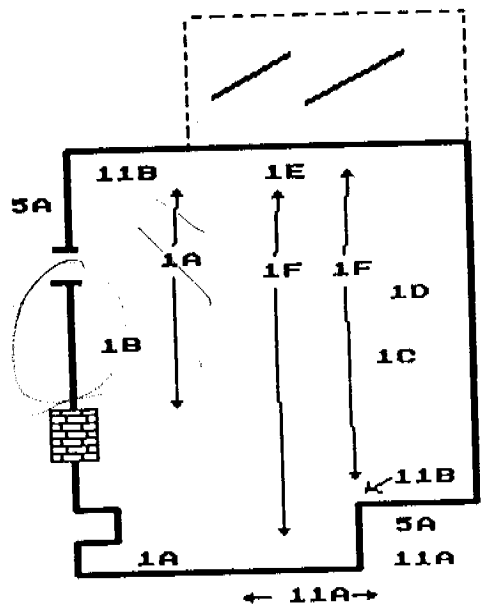
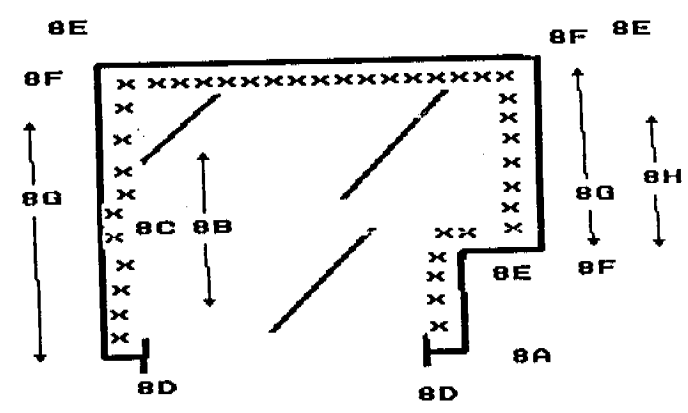
DIAGRAM AND EXPLANATION OF FINDINGS (This report is limited to structure or structures shown on diagram)

Item 1B: Wood boring beetles have damaged wall sheathing and joists in the subarea.

Item 1C: Fungus has damaged the sub-floor and framing beneath the stall shower as viewed from the subarea.

Item 5A: Dry rot has damaged the wood framing of foundation vents.

Item 8A: Dry rot was found at the siding, fascia, roof sheathing and soffit.

Item 8B: A hole in roof covering has caused fungus damage at rafters and roof sheathing and has damaged sheetrock.

Item 8C: Subterranean termites are infesting the wall framing in the garage.

Item 8F: Subterranean termites have damaged the framing and siding in the garage.

*not*  
RECOMMENDATION: Scrape down all termite tubes. Drill a series of holes through the concrete slab adjacent to the wall where marked with X's on the diagram. Pressure inject a registered termiticide into the soil. Fill holes with mortar. All labor and materials are guaranteed for a period of one year. This guarantee is for Subterranean termites and is limited to the immediate treated area only.

*not*  
RECOMMENDATION: Replace the damaged framing and siding. Drill a series of hole through the slab adjacent to the entire foundation footing of the garage. Pressure inject DRAGNET, a registered termiticide into the soil in accordance with the manufacturer's label. Seal the holes with mortar.
