WOOD DESTROYING PESTS AND ORGANISMS INSPECTION REPORT

BUILDING NO: 7652	STREET: Denise Street	CITY: Sacramento	ZIP: 95832	COUNTY CODE: 34	DATE OF INSPECTION: 7/16/00	NUMBER OF PAGES: 4
The Pest Detective PO Box 1835 Loomis CA 95650 Tel 1-800-447-0313 Fax 916-452-6080				Affix stamp here on Board copy only A LICENSED PEST CONTROL OPERATOR IS AN EXPERT IN HIS FIELD. ANY QUESTIONS RELATIVE TO THIS REPORT SHOULD BE REFERRED TO HIMSELF.		
REGISTRATION # PR 3589	REPORT # 100533	STAMP #	ESCROW #

7652 Denise Street
Sacramento, CA 95832

Co. Report #100533 Date: 7/18/00

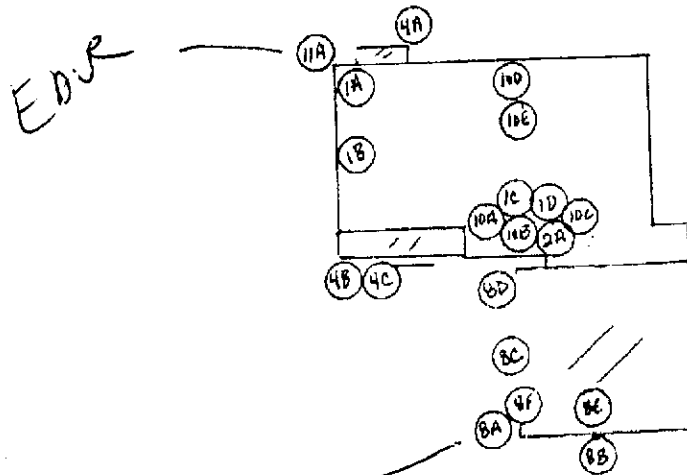
DIAGRAM NOT TO SCALE

✓ A. Finding: Wood boring beetles have damaged the rim joist in the subarea. Indicated by 1A on diagram.

✓ B. Finding: Subterranean termites were noted in the subarea. Indicated by 1B on diagram.

✓ C. Finding: Fungus has damaged subfloor at both bathrooms in the subarea. Indicated by 1C on diagram.

✓ D. Finding: The 2x4 brace is in earth to wood contact. Indicated by 1D on diagram.

✓ A. Finding: The glass enclosure of the stall shower in the master bath was found to be broken and or leaking. Indicated by 2A on diagram.

✓ A. Finding: Fungus has damaged the barge rafter at the rear porch. Indicated by 4A on diagram.

✓ B. Finding: Fungus has damaged the support post pad at the front porch. Indicated by 4B on diagram.

✓ C. Finding: Fungus has damaged the roof trim board and fascia board at the front porch. Indicated by 4C on diagram.

✓ A. Finding: Fungus has damaged the roof sheathing, fascia, and barge rafter at the garage. Indicated by 8A on diagram.

✓ B. Finding: Fungus has damaged the window casing and framing in the garage. Indicated by 8B on diagram.

✓ C. Finding: Fungus has damaged the garage door jambs. Indicated by 8C on diagram.

D. Finding: Missing trim board noted at garage. Indicated by **8D** on diagram.

E. Finding: Missing roof shakes noted at garage. Indicated by **8E** on diagram.

F. Finding: Fungus has damaged the garage door jambs. Indicated by **8F** on diagram.

A. Finding: The vanity in the bathroom is damaged. Indicated by **10A** on diagram.

B. Finding: The underlayment in the hall bathroom is buckled adjacent to the bathtub, indicating possible damage to the subflooring. Indicated by **10B** on diagram.

C. Finding: The enclosure is improperly sealed. Indicated by **10C** on diagram.

D. Finding: The underlayment adjacent to the dishwasher in the kitchen is water damaged. Indicated by **10D** on diagram.

E. Finding: A leak at the kitchen sink and side panels has damaged the cabinet false bottom. Indicated by **10E** on diagram.

A. Finding: Fungus has damaged the barge rafter at the rear side of the structure. Indicated by **11A** on diagram.

Recommendation (1): Remove the damaged rim joist and replace with new material. SECTION I.

Recommendation (2): Tarp and fumigate the structure with Methyl Bromide (active ingredients) methyl bromide and chloropicrin. SECTION I.

Recommendation: Scrape down the termite tubes. Treat the subarea with Premise (active ingredients) Imidacloprid in accordance with the manufacturer's label. SECTION I.

Recommendation: Remove the damaged wood and replace with new materials. SECTION I.

Recommendation: Mount brace on concrete or remove. SECTION II.

Recommendation: Remove and replace the glass enclosure. SECTION II.

Recommendation: Remove the damaged wood and replace with new material. SECTION I.

Recommendation: Cut off the damaged portion of the jambs and pack with concrete. SECTION I.

Recommendation: Install new trim board. SECTION II.

Recommendation: The exterior surfaces of the roof will not be inspected. If you want the water tightness of the roof determined, you should contact a roofing contractor licensed by the Contractor's State License Board.

Recommendation: Remove the toilet. Remove the floor covering and underlayment. Install new underlayment and floor covering of a neutral color. Reset the toilet on a new wax ring. If damage is found to extend into adjacent timbers, a supplemental report will be issued. SECTION I.

Recommendation: Reseal enclosure with waterproof sealant. SECTION II.

Recommendation: Remove the floor covering and underlayment. Install new underlayment and floor covering of a neutral color. SECTION I.

Recommendation: Repair the leak as found to be necessary. Remove damaged false bottom and replace with new materials. SECTION I.
