Site Address: 1537 35TH ST SAC

Nature of Work: DRY ROT REPAIR (SFA SEE REPORT)

# WOOD DESTROYING PESTS AND ORGANISMS INSPECTION REPORT

REGISTRATION # PR 0149	REPORT # 77705B	STAMP #	ESCROW #
---------------------------	--------------------	---------	----------

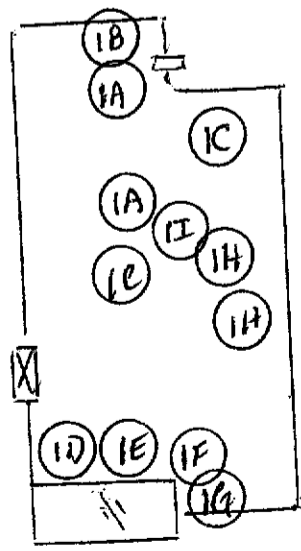
**BY OTHERS**  
Item 1A: Water is leaking from the plumbing in the substructure area in various places. Recommend owner to employ a licensed plumbing contractor to inspect the plumbing and to make necessary repairs.

**ZAP**  
Item 1B: Fungus and dryrot damage is visible in the cripple studs adjacent to the subarea access opening. Replace the damaged wood members with new material. NOTE: The source of the moisture that contributed to the damage appears to be from exterior uncontrollable sources.

**ZAP**  
Item 1C: There is a moderate amount of fungus infected cellulose debris in the subarea. Remove all cellulose debris of a rakeable size and larger.

**ZAP**  
Item 1D: Fungus and dryrot damage is visible in the 2x4 cripples and adjacent top plate in the substructure area. Replace the damaged wood members with new material. NOTE: The source of the moisture that contributed to the damage could not be determined at the time of this inspection and may have been previously corrected.

**BY OTHERS**  
Item 1E: Earth-wood contact at the wood members behind the concrete porch. Break out the concrete along the walls of the building at the concrete porch. Lower the earthfill below the top of the foundation, install metal flashing and seal with concrete.

**BY OTHERS**  
Item 1F: Evidence of wood boring beetles in the cripples and rim joist in the subarea. Tarp and fumigate the entire building with a lethal gas toxic to wood boring beetles. House to be vacant a minimum of 5 days. Not responsible for damage to roof or shrubbery around the building. Owner to remove and replace T.V. antenna.

**ZAP**  
Item 1G: Fungus, dryrot, and wood boring beetles damage is visible in the cripples, rim joist and top plate in the substructure area. Replace the damaged wood members with new material.

**ZAP**  
Item 1H: Fungus and dryrot damage is visible in the floor joists in the substructure area. Replace the damaged wood members with new material. NOTE: Previous repairs have been completed in this area by others and the source of the moisture that contributed to the damage may have been previously corrected.

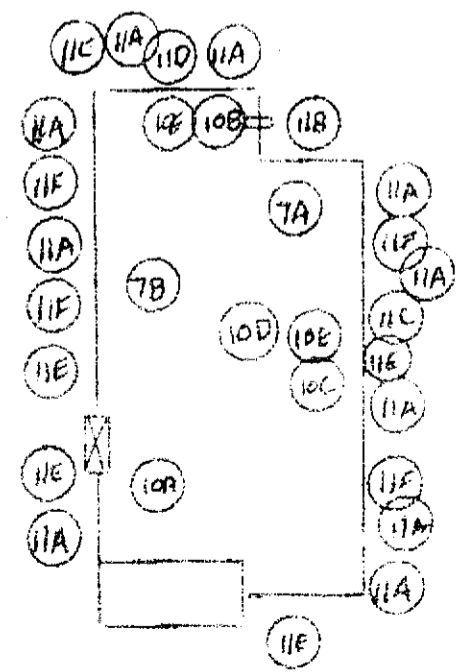
Item 7A: Missing siding at the roof gable is creating large voids that may allow water to enter the attic. Install new siding and seal the voids as necessary.

Item 7B: Water stains were noted on the roof sheathing in the attic. Recommend owner to employ a licensed roofing contractor to inspect the roof and to make any necessary repairs. If a certification of the water tight integrity of the roof, or the roof covering system, is desired, a licensed roofing contractor should be employed.

Item 10A: Water stains were noted on the ceiling. Recommend owner to employ a licensed roofing contractor to inspect the roof and to make any necessary repairs. If a certification of water tight integrity of the roof, or the roof covering system, is desired, a licensed roofing contractor should be employed.

Item 10B: The floor covering is buckled in the laundry room. Fungus and dryrot damage is visible in the framing below. Remove linoleum and underlayment. Remove and replace damaged subfloor and adjacent framing. Install new underlayment and linoleum of a standard grade and neutral color.

Item 10C: Fungus and dryrot damage is visible in the interior window frame. Remove and replace the damaged window frame. No painting included.

Item 10D: The hardwood flooring is buckled in the hallway adjacent to the bathroom. Fungus and dryrot damage is visible in the framing below. Remove up to six square feet of damaged flooring to open this area for further inspection. Render a supplemental report of findings and repair costs.

Item 10E: Grout and/or caulking is missing at the bathtub enclosure and at the kitchen tile countertop. Regrout and caulk as necessary.

Item 11A: Fungus and dryrot damage is visible in the rafter tails, barge rafters, shingle trim, and roof sheathing at the eaves. Replace the damaged wood members with new material.

Item 11B: There are water stains between the deck cover and siding at the rear of the structure, indicating possible roof leaks. Recommend owner to employ a licensed roofing contractor to inspect roof and to make necessary repairs. If a certification of the water tight integrity of the roof or roof covering system is desired, a licensed roofing contractor should be employed.

Item 11C: Earth to wood contact was noted at the base of the siding and adjacent foundation vent trim. Regrade soil as necessary to break earth contacts.

Item 11D: Fungus and dryrot damage is visible in the base of the door casings and adjacent trim at the back door. Replace the damaged wood members with new material.

Item 11E: Fungus and dryrot damage is visible in the window frames at the exterior. Replace the damaged wood members with new material.

Item 11F: Fungus and dryrot damage is visible in the siding and adjacent foundation vent frame at the exterior. Replace the damaged wood members with new material.

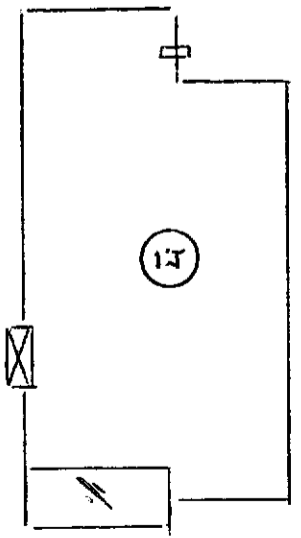
Item 1J: Upon further inspection, and after removing the damaged subfloor and floor joist per item 1I, it was noted the fungus and dryrot had damaged the exposed wall plate and wall studs. The infection and/or damage appears to extend above the subfloor line. Previous repairs have been completed in this area by others. Remove damaged wall plate and wall studs. Inspect exposed areas and render a supplemental report of findings. If no further damage is noted, install new wall plate, wall studs and subfloor. To support the area, install three new properly footed pier posts and new girder. Remove and replace damaged floor joists.

NOTE: We will exercise caution; however, we cannot assure against damage to the tile floor covering during the course of repair. If it becomes necessary to remove any lathe and plaster wall covering at the interior to facilitate repairs, lathe and plaster will be replaced with sheetrock wall board. No painting or texturing included in this estimate.
