**Permit No: 9807896**

**Site Address: 2656 18TH ST SAC**

**Nature of Work: PEST/DRYROT REPAIR IN INTERIOR OF SINGLE FAMILY HOME - PER  
PEST REPORT**

# WOOD DESTROYING PESTS AND ORGANISMS INSPECTION REPORT

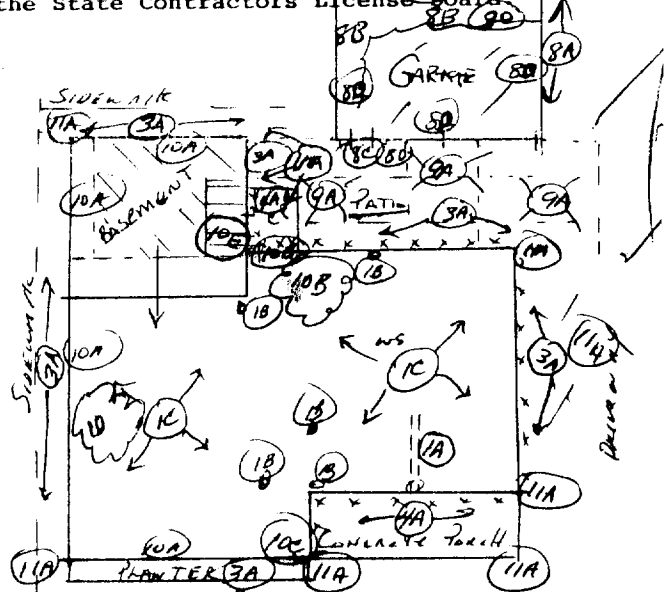
DIAGRAM AND EXPLANATION OF FINDINGS (This report is limited to structure or structures shown on diagram)

**1A. FINDING:** Subterranean Termite damage is visible at 4 X 6 girder.

**1B. FINDING:** There is earth-to-wood contacts at approximately (4) four substructure pier posts.

**1C. FINDING:** Evidence of subterranean termite activity is visible in the cellulose debris scattered throughout the subarea.

**1D. FINDING:** Wood decay fungi (dryrot) damage is visible on the wood members under the ceramic tile floor of the hall bath caused by a leak at commode.

**3A. FINDING:** Subterranean termites are entering the structure from the exterior foundation.

**4A. FINDING:** Subterranean termites are gaining access to the structure from the earth fill of the front and rear concrete porches.

**8C. FINDING:** Wood decay fungi (dryrot) and subterranean termite damage was found at the wood jambs and moldings off the side garage door.

**8D. FINDING:** Subterranean termites are entering the structure from the earth fill of the garage slab.

**9A. FINDING:** The old uncovered wood framing of the patio roof are attached to the structure, garage, and wood fence, and is infected with wood decay fungi (dryrot).

**RECOMMENDATION:** From the subarea, remove all damaged wood members and replace with new material. **\*\*\*This is a Section I Item\*\*\***

**RECOMMENDATION:** Re-grade soil adjacent to pier posts to expose approximately four inches of footings. **\*\*\*This a Section I Item\*\*\***

**RECOMMENDATION:** Remove and dispose of all loose wood scraps and other cellulose debris of rakeable size or larger. Chemically treat subarea soil with "Demon TC" (active ingredient, "Cypermethrin") according to label instructions for the control of subterranean termites. Remove all termite evidence. **\*\*\*This is a Section I Item\*\*\***

**RECOMMENDATION:** Completely remove the ceramic tile floor. Remove all damaged wood members and replace with new materials. Treat adjacent wood members with: "Tim-bor" (active ingredient, "Disodium Octaborate Tetrahydrate") for the control of wood decay fungi. In lieu of replacing ceramic tile flooring, we recommend installing a 3/4 inch plywood underlayment and "Mannington Vega II" vinyl floor covering, in a neutral color. Install new baseboard and reset commode and a new wax seal. **\*\*\*This is a Section I Item\*\*\***

**RECOMMENDATION:** Drill a series of holes through concrete slabs, sidewalks, and driveway at approximately every (2) two feet adjacent to foundation at exterior, chemically pressure treat soil beneath with "Demon TC" (active ingredient, "Cypermethrin") per label instructions for the control of subterranean termites. Fill drilled holes with concrete mortar. Drill approximately (50) fifty holes and treat soil adjacent to foundation at front planter with "Demon TC" (active ingredient, "Cypermethrin") for the control of subterranean termites. \*\*\* (This is a Section I Item)\*\*\*

**RECOMMENDATION:** Drill approximately (15) fifteen holes through the concrete cap and inject "Demon TC" (active ingredient, "Cypermethrin") into the soil below for the control of subterranean termites. Remove all termite evidence. \*\*\* (This is a section I Item)

**RECOMMENDATION:** Remove the damaged sections and replace with new material. Chemically treat adjacent wood members with "Tim-bor" (active ingredient, "Disodium Octaborate Tetrahydrate") per label instructions for the control of wood decay fungi. \*\*\* (This is a Section I Item)\*\*\*

**RECOMMENDATION:** Drill approximately (30) thirty holes through the slab and pressure inject "Demon TC" (active ingredient, "Cypermethrin") into the soil below for the control of subterranean termites. Fill the holes with mortar. Remove all termite evidence. \*\*\* (This is a section I Item)\*\*\*

**RECOMMENDATION:** We recommend entirely removing and hauling away the uncovered portions of the patio roof framing to correct this condition. (Replacement costs NOT included).
