Site Address: 577 SWANSTON DR SAC
Parcel No: 0120161035

Nature of Work: DRYROT AND STUCCO REPAIR ON THE FRONT PORCH AND WINDOWS

WOOD DESTROYING PESTS AND ORGANISMS INSPECTION REPORT

BUILDING NO. 577	STREET SWANSTON DRIVE	CITY SACRAMENTO	ZIP 95811	COUNTY CODE 34	DATE OF INSPECTION 04/14/98	NUMBER OF PAGES 3
---------------------	--------------------------	--------------------	--------------	-------------------	--------------------------------	----------------------

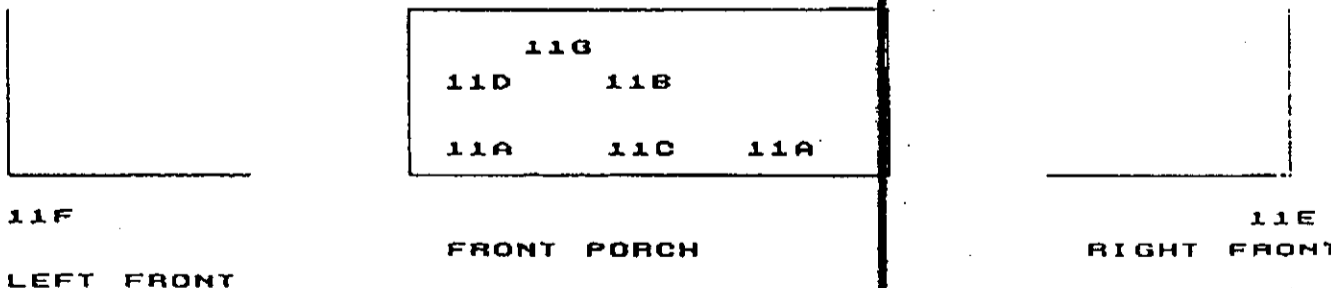
Item 11C: FINDING: DRY ROT AND SUBTERRANEAN TERMITE DAMAGE WAS FOUND IN THE EAVE GIRDER AT THE FRONT PORCH.

Item 11D: FINDING: DRY ROT DAMAGE WAS FOUND TO EXTEND INTO THE WALL FRAMING, STUDS AND STUCCO SHEATHING BEHIND THE STUCCO AND BRICK VENEER AT THE FRONT PORCH.

Item 11E: FINDING: DRY ROT DAMAGE WAS FOUND TO EXTEND INTO THE WALL FRAMING AT THE RIGHT FRONT WINDOW AREA.

Item 11F: FINDING: THERE IS A VOID AT THE BRICK VENEER AT THE LEFT FRONT CORNER.

Item 11G: FINDING: EVIDENCE OF A ROOF LEAK WAS FOUND AT THE FRONT PORCH.

Item 11A: FINDING: EVIDENCE OF SUBTERRANEAN TERMITES WERE FOUND ENTERING THE STRUCTURE BETWEEN THE BRICK VENEER AT FRONT PORCH.

Item 11B: FINDING: DRY ROT WAS FOUND IN THE ROOF SHEATHING, ROOF SHINGLES, RAFTER TAILS, BLOCKING AND EAVE GIRDERS AT THE FRONT PORCH.

RECOMMENDATION: REMOVE THE DAMAGED WOOD MEMBERS AND REPLACE WITH NEW MATERIAL.

RECOMMENDATION: REMOVE THE STUCCO AND BRICK VENEER FOR FURTHER INSPECTION. ISSUE A SUPPLEMENTAL REPORT ON FINDINGS AND RECOMMENDATIONS IF ANY.

RECOMMENDATION: REMOVE THE STUCCO AND THE BRICK VENEER FOR FURTHER INSPECTION. A SUPPLEMENTAL REPORT WILL BE ISSUED ON FINDINGS AND RECOMMENDATIONS IF ANY.

RECOMMENDATION: REMOVE THE BRICK VENEER FOR FURTHER INSPECTION. DRY ROT DAMAGE WAS ALSO FOUND IN WINDOW SILL. REMOVE THE SILL FOR FURTHER INSPECTION. A SUPPLEMENTAL REPORT WILL BE ISSUED ON FINDINGS AND RECOMMENDATIONS IF ANY.

RECOMMENDATION: RECOMMEND A QUALIFIED ROOFER BE EMPLOYED TO INSPECT ROOF AND REPAIR AND/OR REPLACE AS NECESSARY.

RECOMMENDATION: CHEMICALLY TREAT THE ENTIRE SUBAREA. DRILL HOLES THROUGH THE CONCRETE ALONG THE WALLS OF THE FRONT AND REAR PORCHES. INJECT CHEMICAL TOXICANT DEMON T.C. FOR THE CONTROL OF SUBTERRANEAN TERMITES AND SEAL ALL HOLES.

RECOMMENDATION: CUT OUT DRY ROT AND REPLACE WITH NEW MATERIAL.
