Site Address: 4872 10TH AV SAC
Parcel No: 015-0182-010 4872 10TH ST

Nature of Work: REHAB/REPAIR HOUSING CASE, PER FIELD CK LIST & CORRECTION NOTICES

Case Field Check List

ORIGINAL REPORT <input checked="" type="checkbox"/> LIMITED REPORT <input type="checkbox"/> SUPPLEMENTAL REPORT <input type="checkbox"/> REINSPECTION REPORT <input type="checkbox"/>		*Original Structure										
GENERAL DESCRIPTION: <u>ONE STORY SINGLE FAMILY DWELLING</u> <u>COMPOSITION ROOF COVERING</u>		IN ACCESSIBLE AREAS	NOT INSPECTED	FOUNDATION	DRYWOOD TERMITES	FUNGUS ROXY BOY	OTHER WOOD AREA	CEILING	WALL	FLOOR	ROOF	EXTERIOR
INSPECTION TAG POSTED: <u>SUBAREA</u>												
OTHER INSPECTION TAGS:

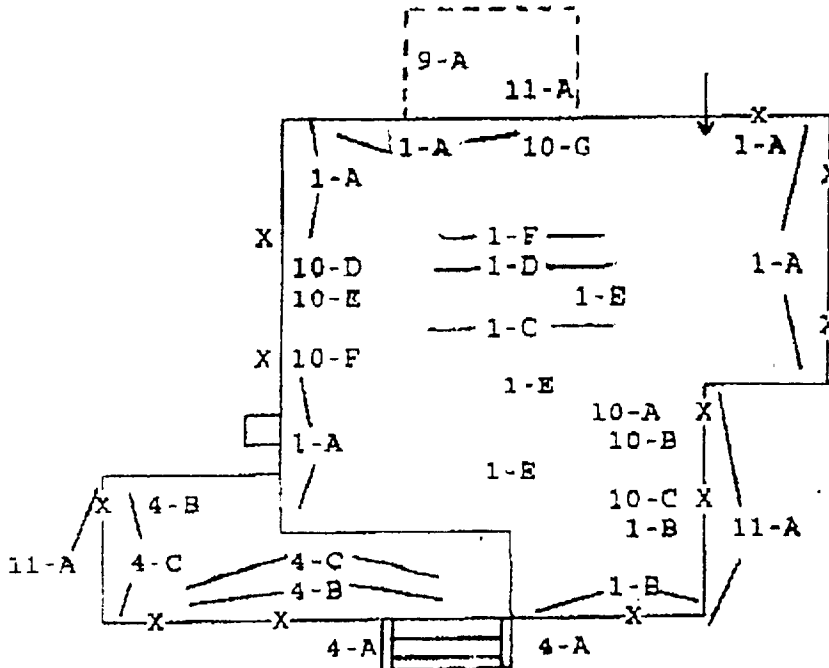
DIAGRAM AND EXPLANATION OF FINDINGS (This is linked to structure or structures shown on diagram)

- 1A. FINDING #1-A - SUBTERRANEAN TERMITE DAMAGE WAS NOTED AT SUBFLOOR, FLOOR
S1 JOIST, CRIPPLE STUDS AND SHEETING IN SUBAREA. SEE 1-A ON DIAGRAM.

- 1B. FINDING #1-B - POWDER POST BEETLE DAMAGE WAS NOTED AT RIM JOIST,
S1 SUBFLOOR, CRIPPLE STUDS AND WALL SHEETING. SEE 1-B ON DIAGRAM.

- 1C. FINDING #1-C - POWDER POST BEETLE INFESTATION WAS NOTED IN SUBAREA.
S1 SEE 1-C ON DIAGRAM.

FINDING #1-D - SUBTERRANEAN TERMITES ACTIVITY WAS NOTED IN SUBSTRUCTURE.
SEE 1-D ON DIAGRAM.

E. FINDING #1-E - EARTH TO WOOD CONTACT WAS NOTED AT SEVERAL GIRDER SUPPORT
1 POST IN SUBAREA. SEE 1-E ON DIGRAM.

A. FINDING #4-A - SUBTERRANEAN TERMITE AND FUNGUS DAMAGE WAS NOTED TO FRONT
1 STEP COLUMNS. SEE 4-A ON DIAGRAM.

B. FINDING #4-B - SUBTERRANEAN TERMITE, FUNGUS AND POWDER POST BEETLE
DAMAGE WAS NOTED AT FRAME WORK UNDER FRONT PORCH. SEE 4-B ON DIAGRAM.

C. FINDING #4-C - EARTH TO WOOD CONTACT WAS NOTED AT PERIMETER OF FRONT
1 PORCH. SEE 4-C ON DIAGRAM.

A. FINDING #5-A - LACK OF VENTILATION HAS CONTRIBUTED TO INFECTIONS AND
1 INFESTATIONS IN SUBAREA.

10A. FINDING #10-A - EXCESSIVE MOISTURE DAMAGE WAS NOTED AT HALL BATH FLOOR.
S1 SEE 10-A ON DIAGRAM.

10B. FINDING #10-B - THE TOILET WAS NOTED MISSING IN HALL BATH. SEE 10-B
S2 ON DIAGRAM.

10C. FINDING #10-C - PLUMBING FIXTURES WERE NOTED MISSING AT BATH TUB. SEE
S2 10-C ON DIAGRAM.

10D. FINDING #10-D - KITCHEN FAUCET AND DRAIN SYSTEM WAS NOTED MISSING. SEE
S2 10-D ON DIAGRAM.

10E. FINDING #10-E - EXCESSIVE MOISTURE DAMAGE WAS NOTED AT KITCHEN FLOOR.
S1 SEE 10-E ON DIAGRAM.

10F. FINDING #10-F - PLUMBING LEAK HAS CAUSED DAMAGE TO STORAGE SHELF UNDER
S1 KITCHEN SINK. SEE 10-F ON DIAGRAM.

FINDING #10-G - EXCESSIVE MOISTURE DAMAGE WAS NOTED AT HALF BATHROOM FLOOR. SEE 10-G ON DIAGRAM.

11A. FINDING #11-A - FUNGUS DRY ROT DAMAGE WAS NOTED AT ROOF EAVES. SEE 11-A S1 ON DIAGRAM.

#1-A - REMOVE STUCCO TO EXPOSE ALL DAMAGE. REMOVE AND REPLACE ALL DAMAGED MATERIAL. RESTUCCO EXPOSED AREAS AS NEEDED.

#1-B - REMOVE STUCCO TO EXPOSE ALL DAMAGE. REMOVE AND REPLACE ALL DAMAGED MATERIAL. RESTUCCO EXPOSED AREA AS NEEDED.

#1-C - TARP AND FUMIGATE DWELLING USING METHYL BROMIDE FOR CONTROL OF POWDER POST BEETLES.

#1-D - TREAT SUBAREA SOIL WITH TRIBUTE FOR THE CONTROL OF SUBTERRANEAN TERMITES. ALSO TRENCH AND TREAT EXTERIOR FOUNDATION USING THE SAME MATERIAL.

#1-E - INSTALL NEW SUPPORTS AS NEEDED ON CONCRETE FOOTINGS.

#4-A - REMOVE AND REPLACE ALL DAMAGED MATERIAL. SEE ITEM 1-D FOR TREATMENT DIRECTIONS.

#4-B - REMOVE AND REPLACE ALL DAMAGED MATERIAL. SEE ITEM 1-C AND 1-D FOR TREATMENT DIRECTION.S

#4-C - INSTALL CONCRETE FOUNDATION AS NEEDED TO CORRECT CONDITION.

#5-A - INSTALL APPROXIMATELY 12 VENTS WHERE INDICATED BY X'S ON DIAGRAM.

#10-A - REMOVE AND REPLACE ALL DAMAGED MATERIAL. INSTALL NEW VINYL FLOOR COVERING. RESET TOILET ON NEW WAX SEAL.

#10-B - INSTALL NEW TOILET.

#10-C - INSTALL NEW FIXTURES.

#10-D - INSTALL NEW FAUCET AND DRAIN SYSTEM.

#10-E - REMOVE AND REPLACE DAMAGED MATERIAL. INSTALL NEW VINYL FLOOR COVERING.

#10-F - REMOVE AND REPLACE DAMAGED STORAGE SHELF.

#10-G - REMOVE AND REPLACE ALL DAMAGED MATERIAL. INSTALL NEW VINYL FLOOR COVERING. RESET TOILET ON NEW WAX SEAL.

#11-A - REMOVE AND REPLACE ALL DAMAGED MATERIAL.
