Nature of Work: RIM JOIST, MUDSILL, STUCCO

WOOD DESTROYING PESTS AND ORGANISMS INSPECTION REPORT

BUILDING NO. 3735/37	STREET Erlewine Circle	CITY Sacramento	ZIP 95819	COUNTY CODE 34	DATE OF INSPECTION 04/26/00	NUMBER OF PAGES 5
-------------------------	---------------------------	--------------------	--------------	-------------------	--------------------------------	----------------------

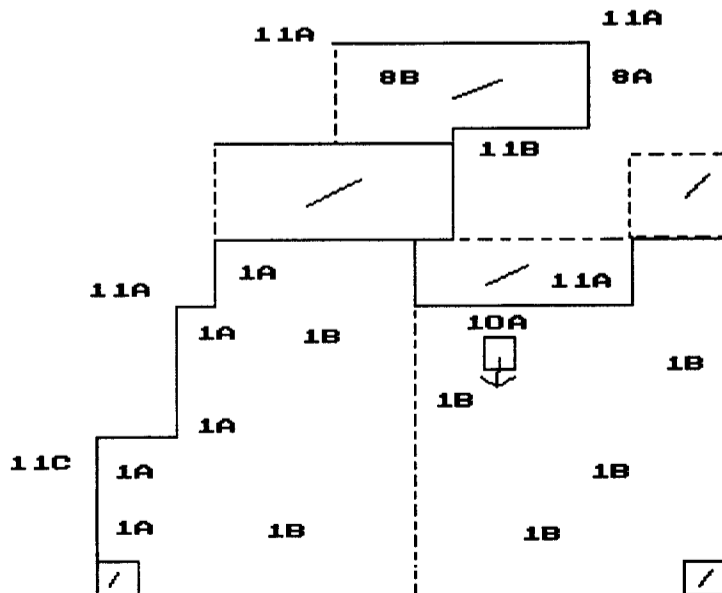
DIAGRAM AND EXPLANATION OF FINDINGS (This report is limited to structure or structures shown on diagram)

Item 1A: FINDING: Wood decay fungi damage is visible at the rim joist and mudsill at the vent openings.

Item 1B: FINDING: Cellulose debris is scattered throughout the subarea. This condition is conducive to an infestation of wood-destroying organisms.

Item 8A: FINDING: Wood decay fungi (dry rot) damage is visible at the base of the jambs of the rear garage door.

Item 8B: FINDING: The interior of the rear garage was not inspected due to lack of key.

Item 10A: FINDING: There is water damage to the floor covering and underlayment of the half bath caused by toilet leakage.

Item 11A: FINDING: There is evidence of wood decay fungi (dry rot) damage at the plywood sheathing, barge rafters, fascia, and rafter tails of the roof overhang.

FINDING: There is wood decay fungi (dry rot) damage at the water heater closet door.

FINDING: There is wood decay fungi (dry rot) damage at the air conditioning window trim.

RECOMMENDATION: Remove exterior stucco to expose damaged areas. Remove all damaged wood members and replace with new material. Treat adjacent wood members with copper naphthenate and restucco the exterior at the exposed areas. SECTION I

RECOMMENDATION: Remove and dispose of all loose wood scraps and other cellulose debris of rakeable size or larger. SECTION II

RECOMMENDATION: Cut off the base of the jambs to remove all damage and pack the resultant voids with mortar. SECTION I

RECOMMENDATION: Inspect the garage. SECTION II FURTHER INSPECTION

RECOMMENDATION: Remove the commode. Remove the damaged portion of floor covering and underlayment. Install new underlayment as needed, and install complete new vinyl floor covering. Reset the commode on a new wax seal. SECTION I

RECOMMENDATION: Remove the roof covering to expose the damaged areas if necessary. Remove all structurally damaged wood members and replace with new material. Install roof covering to the exposed areas only. NOTE: Guarantee applies to the roof covering in the repaired areas only. SECTION I

RECOMMENDATION: Remove and dispose of damaged door. Install a new door according to current local building codes. SECTION I

RECOMMENDATION: Remove all damaged wood and replace with new material. SECTION I
