Site Address: 615 NORTHFIELD DR SAC

Nature of Work: BUSTER -DRY ROT REPAIR Q.FEE J.R.

WOOD DESTROYING PESTS AND ORGANISMS INSPECTION REPORT

BUILDING NO 615	STREET Northfield Drive	CITY Sacramento	ZIP 95833	COUNTY CODE 34	DATE OF INSPECTION 9-23-98	NUMBER OF PAGES 6
--------------------	----------------------------	--------------------	--------------	-------------------	-------------------------------	----------------------

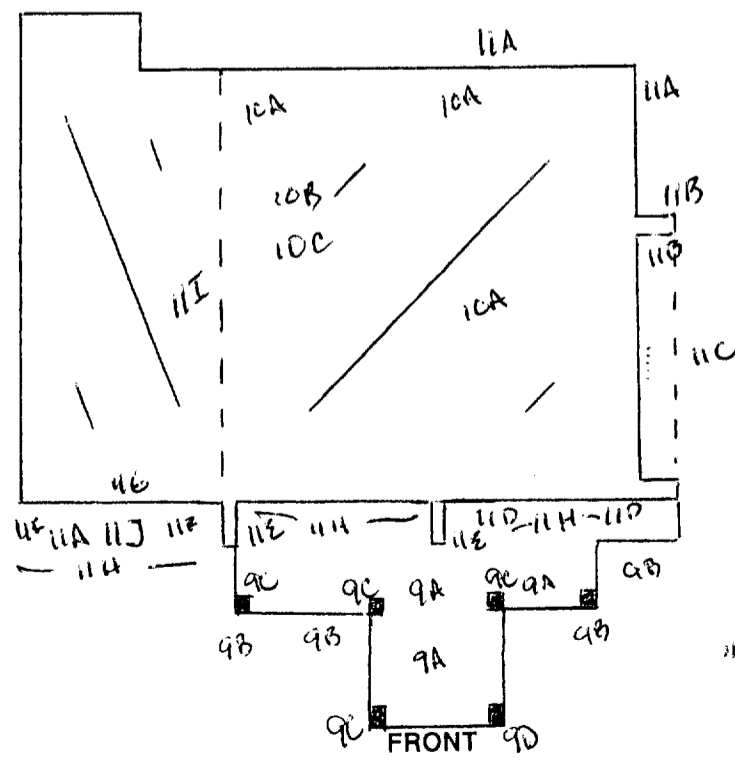
DIAGRAM AND EXPLANATION OF FINDINGS (This report is limited to structure or structures shown on diagram) Scale 1 inch = 20 feet

FINDING 9A: Fungus infection and damage noted to several 4x12 beams and blocking at the front arbor. - Section 1 Item

FINDING 9B: Fungus infection and damage noted to the ends at several beams. - Section 1 Item

FINDING 9C: Earth-wood contact, evidence of subterranean termite infestation, fungus infection, and damage noted at four 6x6 support posts. - Section 1 Item

FINDING 9D: Earth-wood contact, evidence of drywood termite infestation, fungus infection, and damage noted at one 6x6 post and 2x4 bench slats. - Section 1 Item

FINDING 11B: Fungus infection and damage noted to the wood siding 1x4, 2x10 and 2x4 trim at the right side of the structure. - **Section 1 Item**

FINDING 11C: Fungus infection and damage noted to the 2x12 fascia at the right side of the structure. - **Section 1 Item**

FINDING 11D: Fungus infection and damage noted to the wood siding, window and door trim at the front entry. - **Section 1 Item**

FINDING 11E: Fungus infection and damage noted to the wood siding and trim at both bump out and at front of the structure. - **Section 1 Item**

FINDING 11F: Fungus infection and damage noted to the wood siding at the left front wall for approximately 20'. - **Section 1 Item**

FINDING 11G: Fungus infection and damage noted to the 1x4 trim around the attic vent. - **Section 1 Item**

FINDING 11H: Fungus infection and damage noted to the 2x12 trim/ledger at the front of the structure. - **Section 1 Item**

FINDING 11I: Fungus infection and damage noted to the wood siding at the second story wall. - Section 1 Item

FINDING 11J: Earth-wood contact noted at the base of the wood siding. - Section 2 Item

RECOMMENDATION 9A: Remove and replace the damaged beams.

RECOMMENDATION 9B: Cut off all damaged portion of approximately twelve beams.

RECOMMENDATION 9C-1: Remove and replace the damaged posts on metal anchors set in concrete.

RECOMMENDATION 9C-2: Drill through the concrete slab at the front of building and next to all supports and pressure treat soil with the registered termiticide, Premise (Imidacloprid). Seal the drill holes. Remove all accessible subterranean termite tubing. Western Exterminator Company will not be responsible for damage to hidden pipes, conduits or ducts, or their repair.

RECOMMENDATION 9C-3: Chemically treat all exterior and interior perimeters of the structure with the registered termiticide, Premise (Imidacloprid). Drill and treat areas where there is concrete. Seal the drill holes. Western Exterminator Company will not be responsible for damage to or repair of floor covering, hidden pipes, conduits, or ducts or their repair.

RECOMMENDATION 9D: Remove and replace the damaged 6x6 post on a metal anchor set in concrete. Replace damaged portion of 2x4 bench slats.

RECOMMENDATION 11B: Remove and replace the damaged siding and trim.

RECOMMENDATION 11C: Remove and replace the damaged fascia.

RECOMMENDATION 11D: Remove and replace the damaged siding and trim.

RECOMMENDATION 11E: Remove and replace the damaged siding and trim.

RECOMMENDATION 11F: Remove and replace the damaged siding.

RECOMMENDATION 11G: Remove and replace the damaged 1x4 trim.

RECOMMENDATION 11H: Remove and replace the damaged 2x12 trim/ledger.

RECOMMENDATION 11I: Remove and replace the damaged siding.

RECOMMENDATION 11J: Lower the soil to eliminate earth-wood contact.
