Nature of Work: FIRE REPAIR IN LAUNDRY ROOM TO REPLACE STRUCT. ELEMENTS
LIKE FOR LIKE, ELECTR. AND PLUMB. NO EXTERIOR WORK

Sacramento Fire Department - Incident Report

Re: Walker House Repair
2141 2nd Avenue, Sacramento, CA 95818
EFI Job Number: 94605-24171

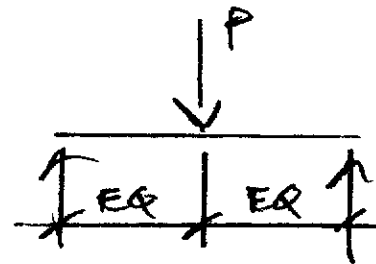
$V = 754 < 2672 \#$

$M = 4524 < 6631 \#ft$

USE 2x12 EA. SIDE OF 4x4 POST (NAILED)
