Special Inspection Final Report
CORTI BROTHERS ROOF REPAIR
Folsom Boulevard, Sacramento, California
Permit No. 04-16190
WKA No. 6106.81

COMPRESSION TEST REPORT

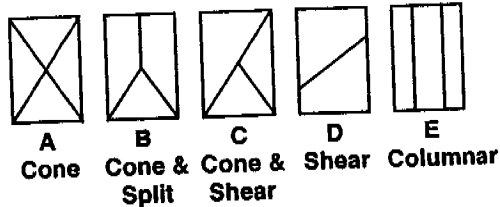
TYPES OF FRACTURE

| SPECIMEN LAB NO. | 1983 | 1984 | 1985 |
|---|---|---|---|
| Fracture Type | A | | |
